# Property Inspection Report

**2431 Plummer Avenue, San Jose, CA 95125**

Donald Grenier  
January 27, 2010  
Report No. 138642

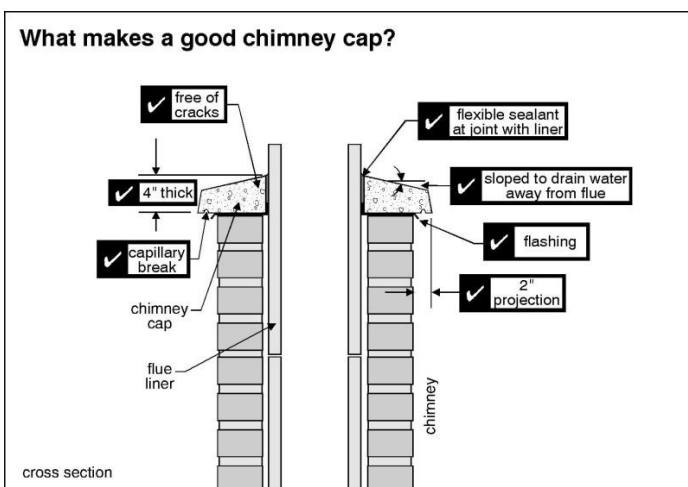
Illustration 3E

3. The cap of the masonry chimney has minor cracking visible which can be patched during regular household maintenance. (See Illustration 3E)
4. The chimney does not have a spark arrestor or rain cap. A rain cap and/or screen should be installed on the masonry chimney. (See Illustration 3I)

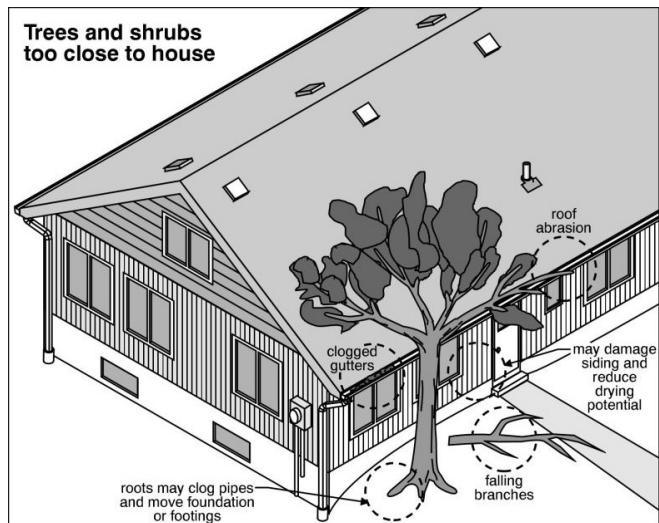
Illustration 8E

6. The proximity of the tree at the right side and front walls could disrupt drainage pipes, cause mechanical damage to the exterior of the house or influence the foundation over time. For additional information and recommendations we recommend appropriate trades be consulted. (See Illustration 8E)

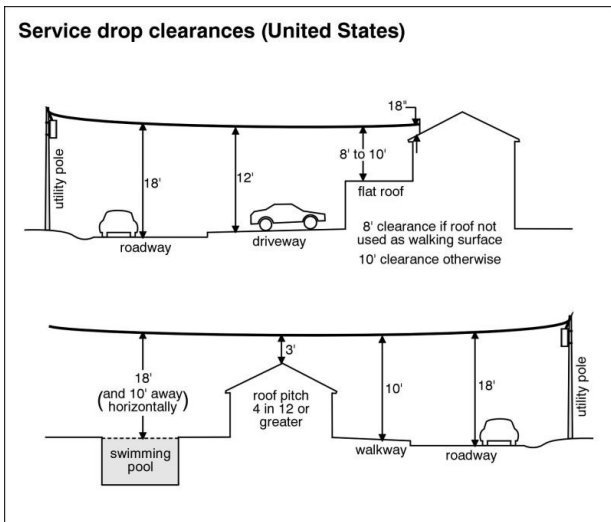
Illustration 2A

- ! 8. The overhead service wires supplying power to the detached garage do not have adequate clearance from the ground and/or non-conforming. We recommend removal or replacement with approved overhead configuration or underground installation. (See Illustration 2A)

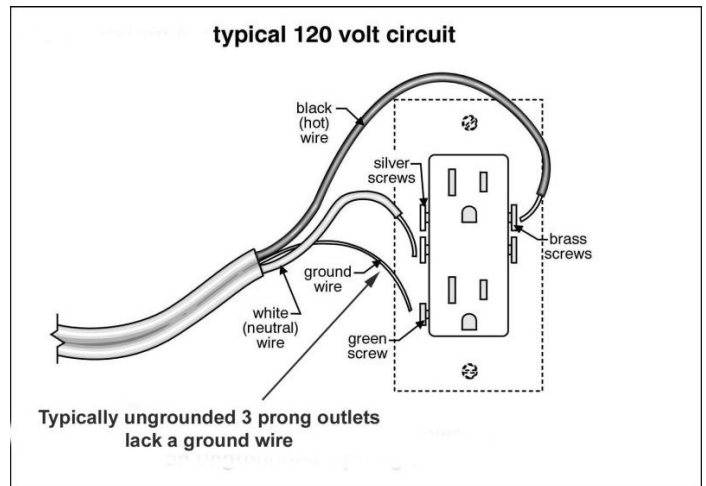
Illustration 100

- ! 1. Ungrounded 3-prong interior outlets at various areas should be improved. A grounded cable or ground wire could be strung to these outlets, the outlet labeled as ungrounded or the original 2-prong receptacle could be reinstalled. If applicable, some electrical codes allow the installation of a ground fault circuit interrupter (GFCI) type receptacle where grounding is not provided. Based upon our inspection of a representative number of outlets, we recommend testing of every outlet. Repairs or rewiring are recommended at all deficient locations. For additional information we recommend a licensed electrician be consulted. (See Illustration 10O)

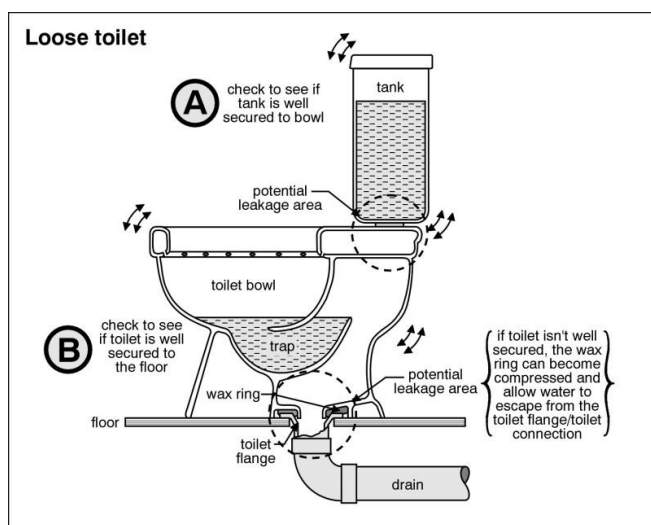
Illustration 5B2

26. The toilet in the hall bath is loose and should be properly re-secured, tightened and caulked. (See Illustration 5B2)
27. The left side crawl space sewer line and hall bathroom tub drain are leaking into the crawl space. We recommend all leaks be repaired.

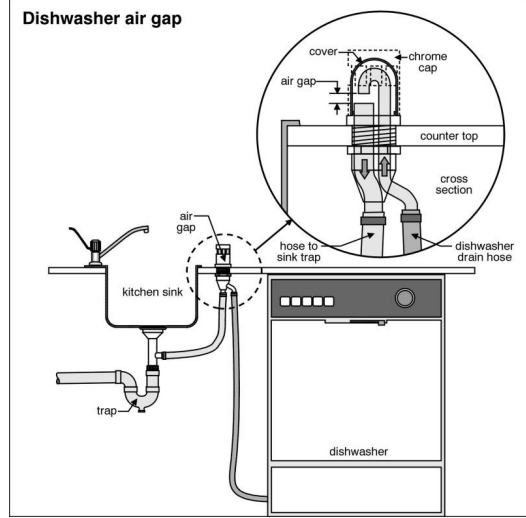
Illustration 4E

30. The kitchen countertop is water damaged in the areas under and around the sink where water leakage has occurred. We recommend the advice and services of a licensed structural pest control operator for investigation and repair of this condition. (See Picture 11)
31. The dishwasher lacks an airgap device. Air gaps are standard equipment to assure a separation between supply and waste water of the dishwasher. It is advised that one be installed. (See Illustration 4E)

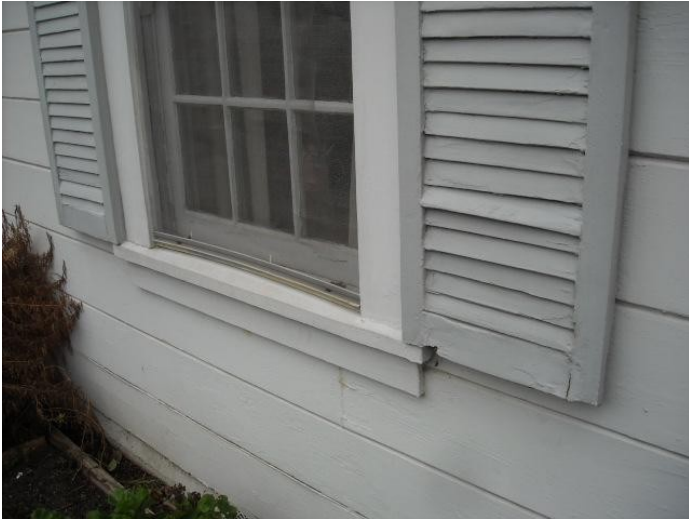
Picture 3

12. It may be desirable to repair or replace the window screens where damaged.
- ! 13. The side decorative shutters are damaged. We recommend they be repaired or replaced as necessary. (See Picture 3)

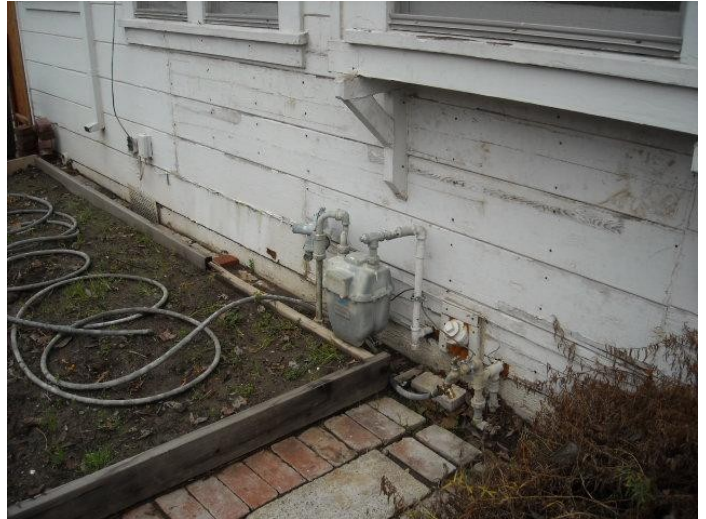
Picture 4

- ! 10. Damaged or cracked siding was noted at the left side exterior wall. We recommend the siding be repaired or replaced as necessary. (See Picture 4)

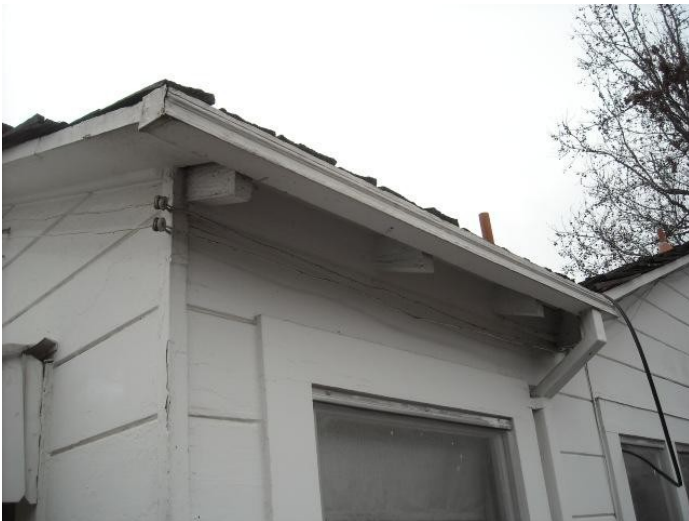
Picture 5

- ! 11. We found exposed exterior wiring at the left side wall. Even if insulated, we recommend all wiring be encased in conduit or otherwise protected in accordance with present standards. (See Picture 5)

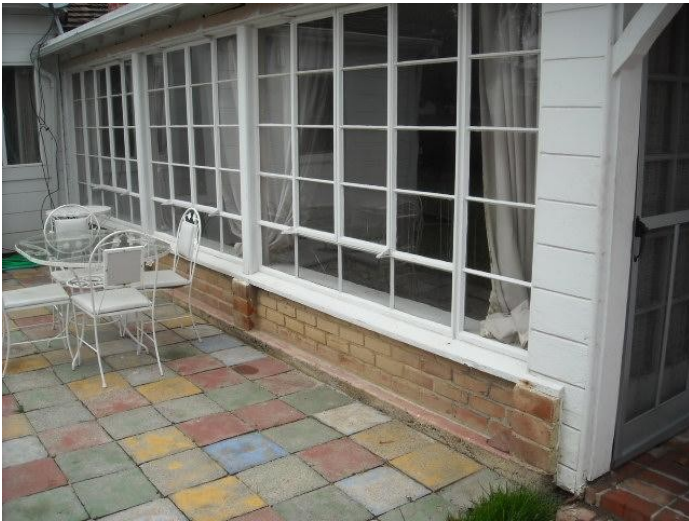
Picture 7

- ! 8. Loose gutters at the rear should be repaired or replaced as necessary. (See Picture 7)
- ! 9. The deteriorated wood gutters at the side and front should be replaced as necessary.

- ! 2. Cracked or broken exterior window's glass at the rear and front should be replaced. (See Picture 7)
3. The rear window(s) near the floor or doors lack tempered glass (special safety glass that will not shatter). For safety reasons, it may be wise to consider the installation of tempered glass where appropriate. The following areas are required to have tempered glass in accordance with today's standards:

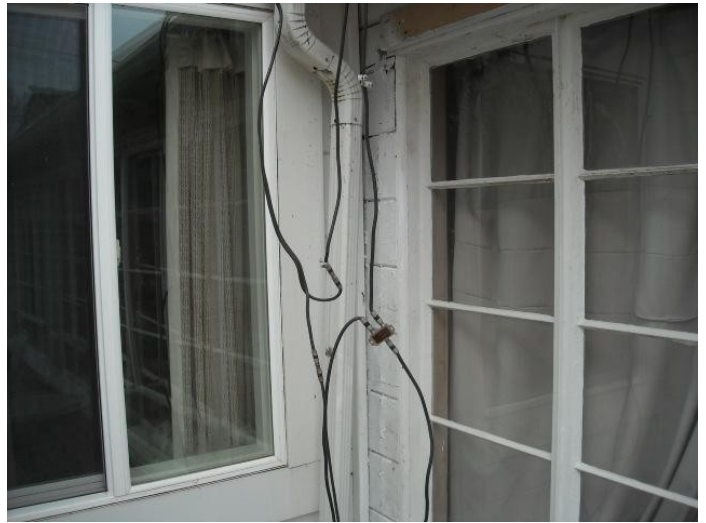
Picture 10

- ! 5. Loose downspouts at the rear should be repaired or replaced as necessary. (See Picture 10)
6. The downspout(s) should discharge water at least five (5) feet from the house. Water should be encouraged to flow away from the building at the point of discharge. The installation of underground drainage were applicable may help to control surface drainage.

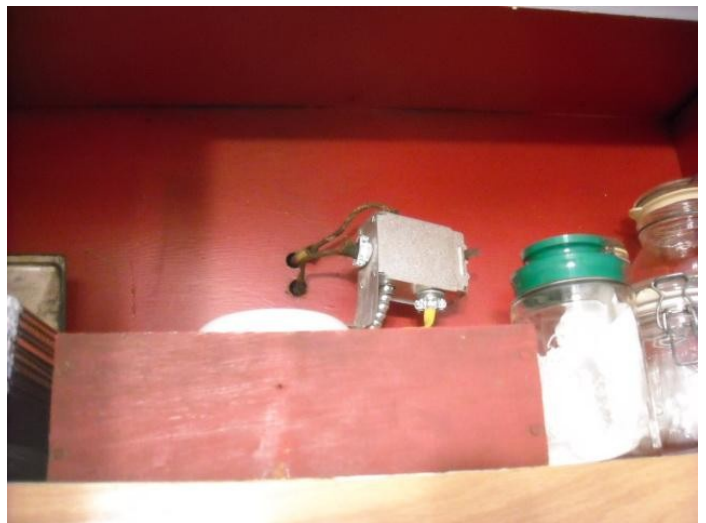
Picture 12

4. Exposed wiring on interior finishes in the kitchen cabinet should be relocated, covered or protected by rigid conduit. (See Picture 12)
5. Knob and tube wiring is in use in this building. This is an outdated system, but is not necessarily hazardous simply because it is old. However, primarily because the knob and tube circuits are generally not grounded, and because of its age, we recommend replacement of the older wiring over time, as upgrades and maintenance projects are undertaken.

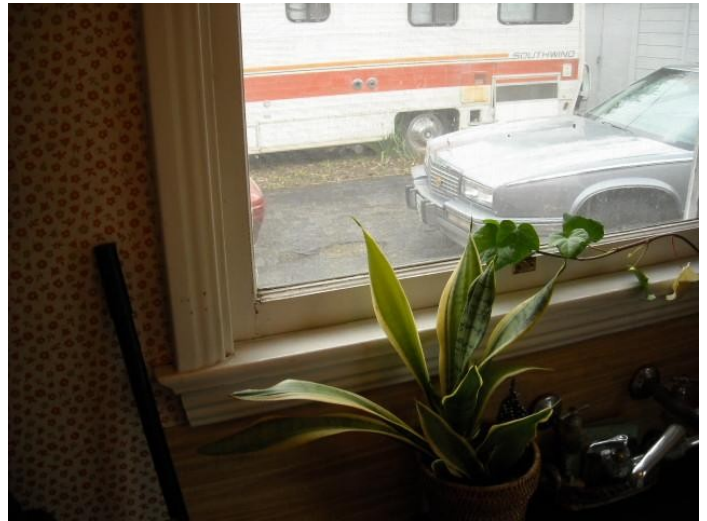
Picture 14

- ! 4. The window frames/sash at the side wall show evidence of water damage. Repair or replacement is recommended by appropriate trades. (See Picture 14) (See Picture 15)

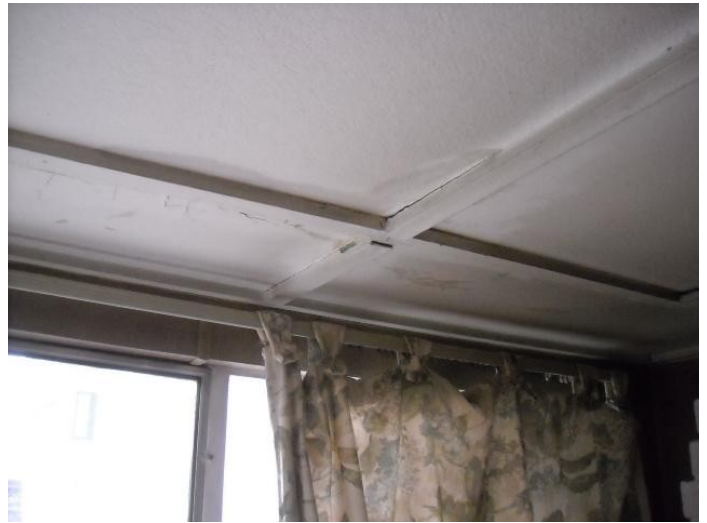
Picture 17

34. The ceiling at the rear family room and bedroom shows evidence of water stains. It is recommended that the source of these stains be identified and corrected and the surface be refinished to restore its appearance. (See Picture 17)

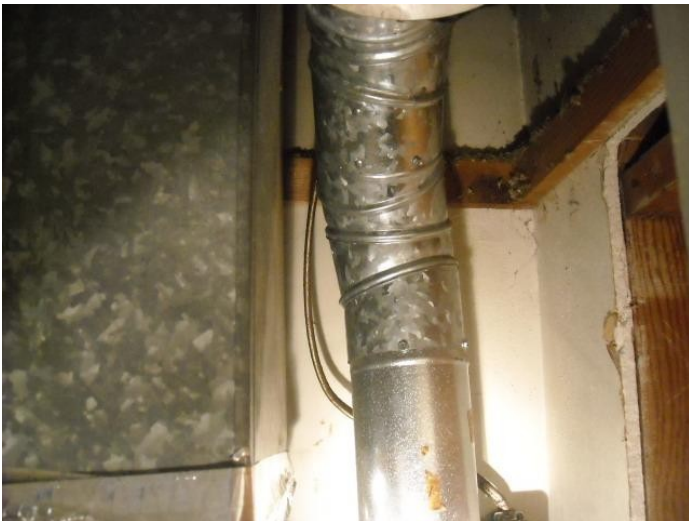
Picture 18

- ! 5. There is insufficient clearance between the exhaust flue and combustible materials. This should be improved. (See Picture 18)
6. The heating system is dirty and in this condition will operate inefficiently. We recommend a qualified H.V.A.C contractor be retained to service, clean, and tune the system.
