# WOOD DESTROYING PESTS AND ORGANISM INSPECTION REPORT

Building No. <b>2431</b>	Street <b>Plummer Avenue</b>	City <b>San Jose</b>	ZIP <b>95125</b>	Date of Inspection <b>1/27/2010</b>	Number of Pages <b>Page 1 of 9</b>
-----------------------------	---------------------------------	-------------------------	---------------------	--	---------------------------------------

HomeGuard Rpt #: **138642**

General Description: <b>One story, single family wood framed residence with wood exterior.</b>	Inspection Tag Posted: <b>Subarea</b> Other Tags Posted: <b>None noted</b>
--	---

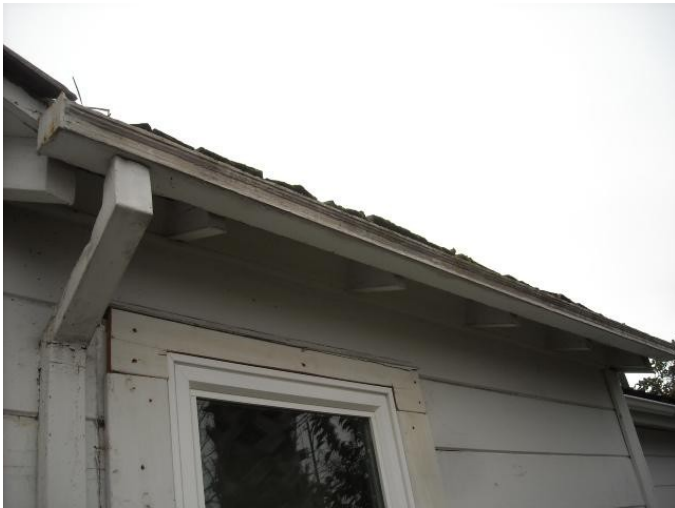
Picture 1

**1A. FINDING:** The wooden rain gutters have been damaged by fungus at the area indicated on the diagram. (See Picture 1) (See Picture 2) (See Picture 5)

**RECOMMENDATION:** Remove the wooden rain gutters. Supply and install new plastic /metal rain gutters and downspouts.

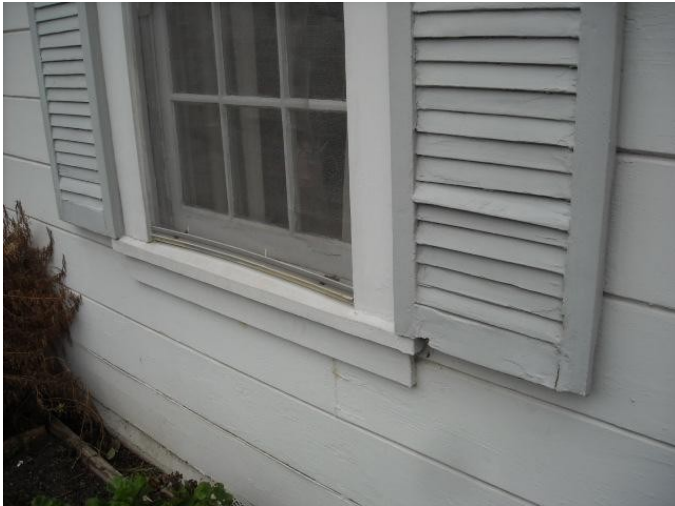
Picture 3

**1B. FINDING:** The shutters have been damaged by fungus at the side wall/window. (See Picture 3)

**RECOMMENDATION:** Remove and replace all the damaged wood members. If any damage is found to extend into any enclosed areas a supplemental report and bid will be issued.

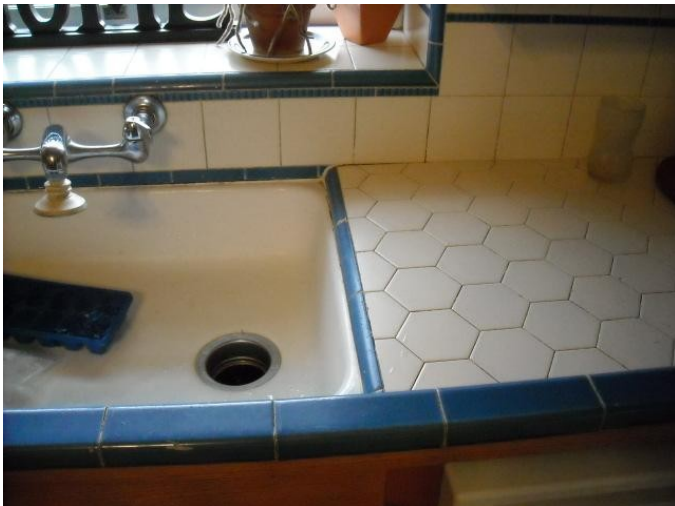
Picture 11

**1C. FINDING:** Water has penetrated through the kitchen counter top and has caused fungus damage. (See Picture 11)

**RECOMMENDATION:** Remove the existing counter top. Remove and replace any fungus damaged wood members. Install a new ceramic tile counter top in this area. Unless prior arrangements have been made, all tile is bid using a standard grade white tile with a tight white grout joint. It should also be noted that all tile work, regardless of color selection, will be done with a tight white grout joint, unless specified differently.

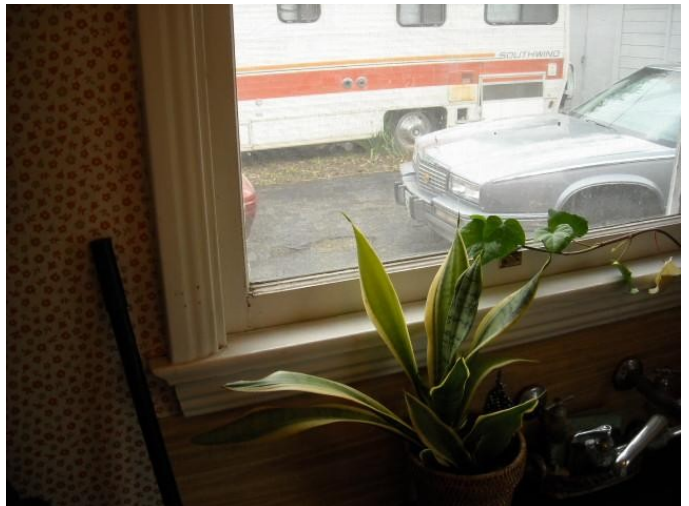
Picture 14

**1D. FINDING:** The wooden window sash has been damaged by fungus at the area indicated on the diagram. (See Picture 15) (See Picture 14)

**RECOMMENDATION:** Replace the entire window sash with a new wooden window sash. Please note that in order to complete this item, there could possibly be a two week delay in getting the new windows milled. At the owners request a bid can be supplied for replacing this widow with an energy efficient style window.
