Roof Inspection Report

7121 Sheehan Court, San Jose

Ernest (Andy) Rodriguez
February 9, 2010
Report No. 139089

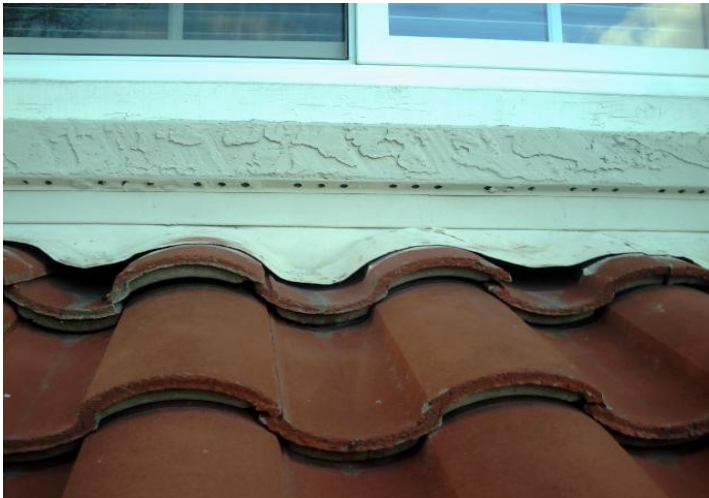
Picture 1

1. The front roof to wall flashing is not properly secured and is pulling up and away from the roof's surface. (See Picture 1)

Secure the front roof to wall flashing as necessary to make watertight.

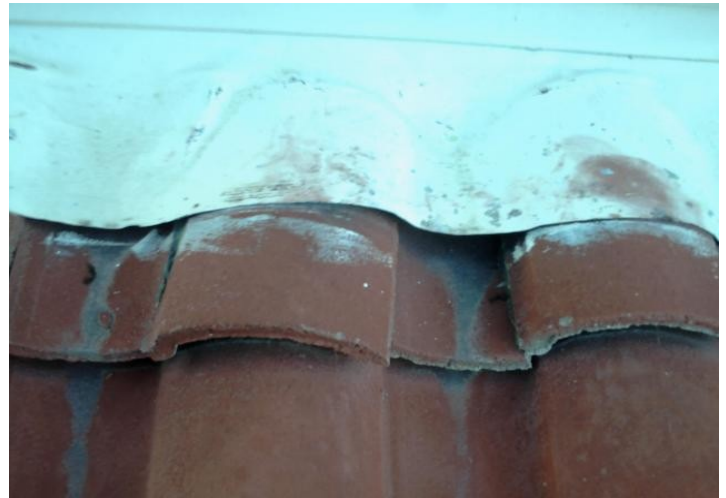
Picture 2

2. Previous repairs have been performed to the roofing system at several areas. These repairs have deteriorated and must be re-done. (See Picture 2) (See Picture 3) (See Picture 9)

Repair previous repairs that have deteriorated.

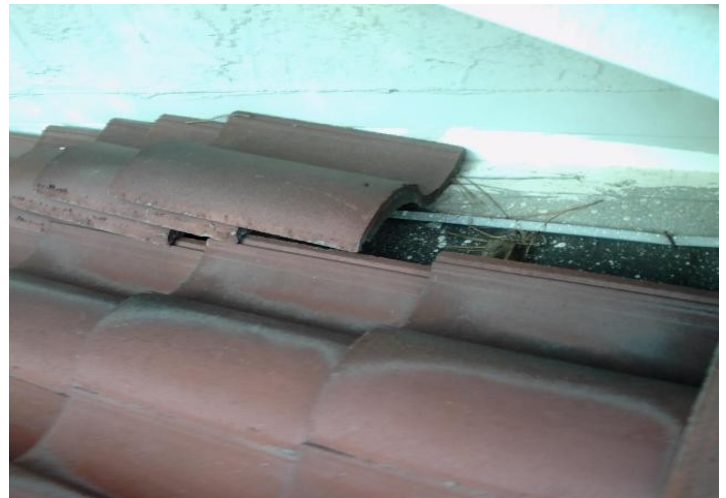
Picture 4

3. The tiles at the left and right side roof to wall are not properly secured and have slipped out of position. This condition is allowing water to penetrate the roof covering and may lead to subsequent leakage. (See Picture 4) (See Picture 15) (See Picture 24)

Reposition the tiles as needed to prevent leakage.

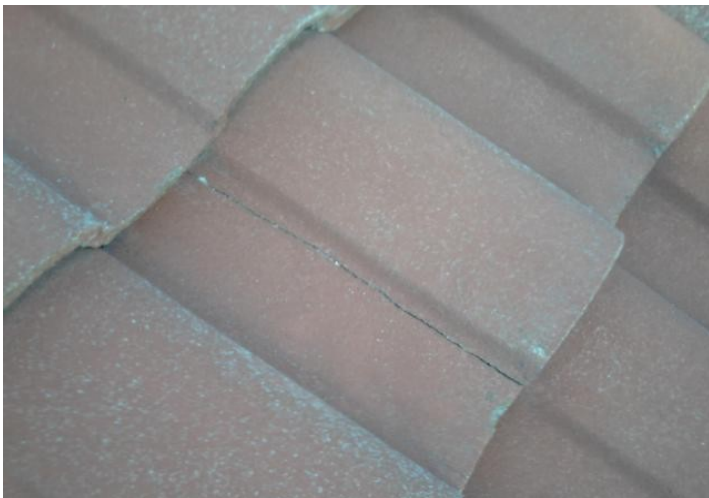
Picture 5

4. During the course of this inspection we noted 8+ broken and/or cracked field tile(s) . (See Picture 5) (See Picture 6) (See Picture 7) (See Picture 14) (See Picture 18) (See Picture 19) (See Picture 22) (See Picture 23)

Repair and/or replace broken and/or cracked field tile(s) where we deem necessary.

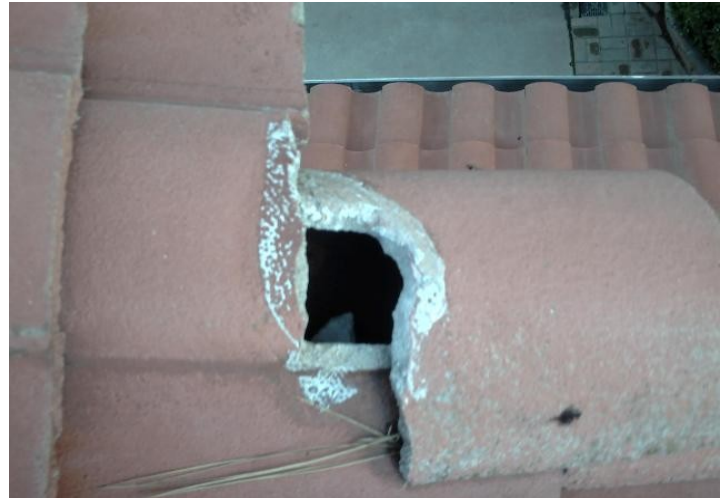
Picture 8

5. The front second story rake to field intersection is lacking a proper seal, subsequently water may penetrate the roofing system. (See Picture 8)

Seal the front second story rake to field intersection as necessary.

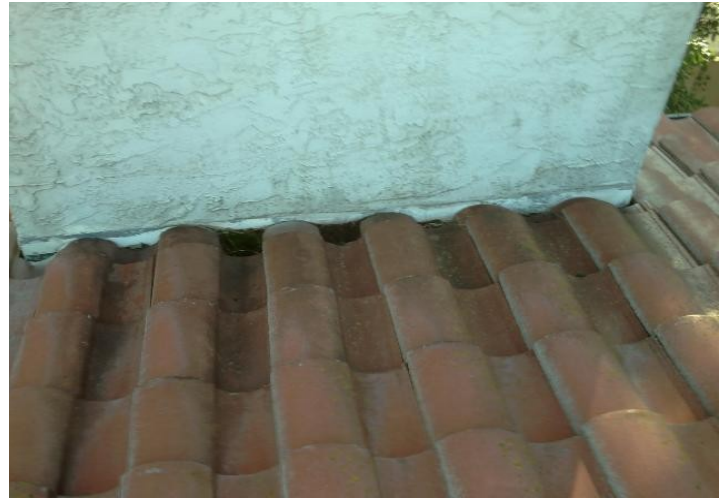
Picture 10

6. Debris has collected behind the chimney and may cause water to backup into the structure. (See Picture 10)

Clear all debris from behind the chimney, this is a one time service.

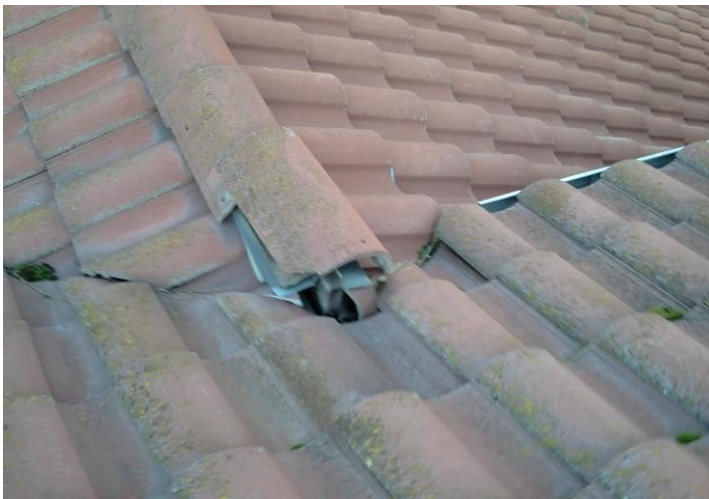
Picture 11

7. During the course of this inspection, we noted one loose ridgeline tile(s). (See Picture 11)

Repair and/or replace ridgeline tiles as necessary.

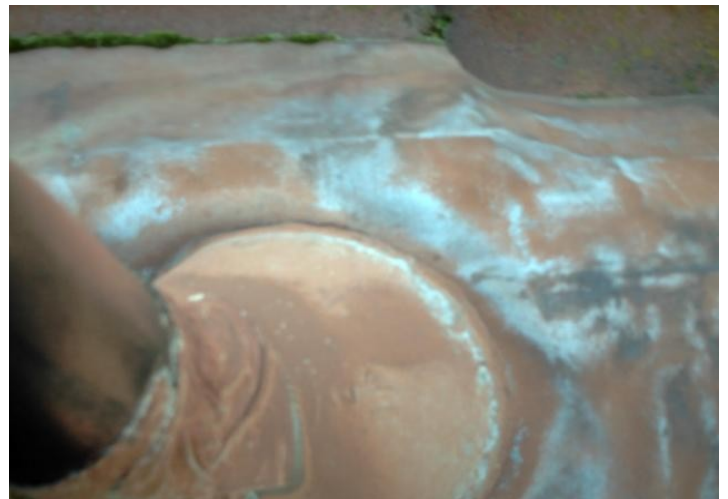
Picture 12

8. Two plumbing and heating flashing has tears and puncture holes. This area appears vulnerable to leakage. (See Picture 12) (See Picture 13)

Repair the rips and/or puncture holes in the lead plumbing and heating flashing where needed.

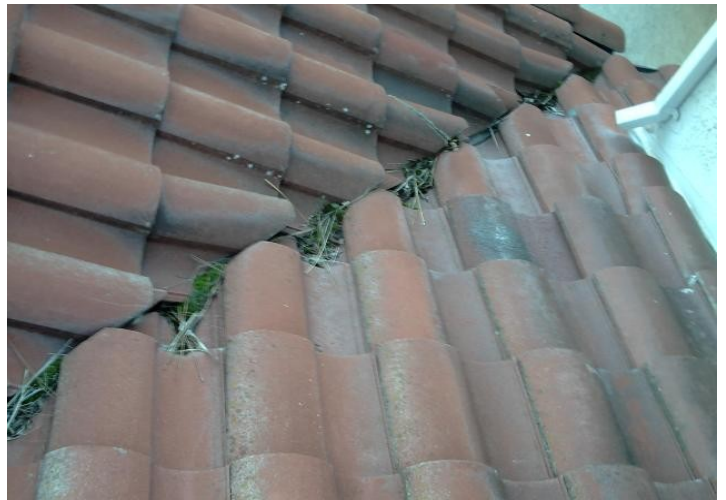
Picture 16

9. Debris is impeding water travel at the valley. (See Picture 16) (See Picture 17)

Remove debris from the valley. This is a one time service.

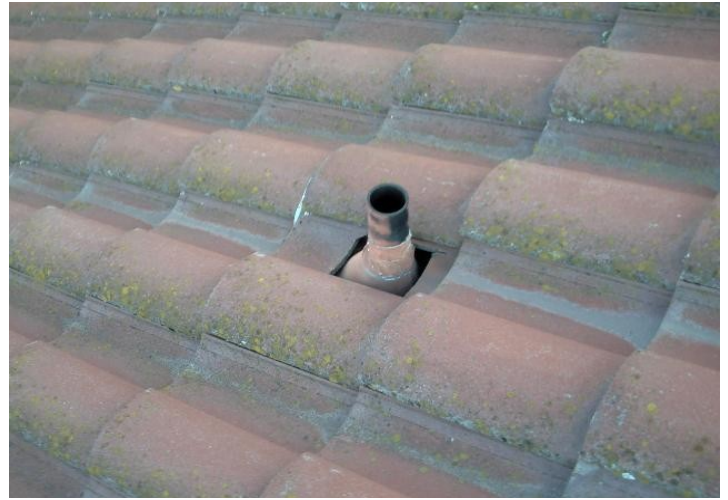
Picture 20

10. We noted two plumbing and heating areas that were the tiles are impacting water travel. This condition does not allow for proper drainage. (See Picture 20) (See Picture 21)
