WOOD DESTROYING PESTS AND ORGANISM INSPECTION REPORT

Building No. 7121	Street Sheehan Court	City San Jose	ZIP 95120	Date of Inspection 2/10/2010	Number of Pages Page 1 of 7
-----------------------------	--------------------------------	-------------------------	---------------------	--	---------------------------------------

HomeGuard Rpt #: **139089**

General Description: Two story single family wood framed residence with stucco exterior. Limited to the main structure only excluding the patio cover.	Inspection Tag Posted: Garage
	Other Tags Posted: None noted

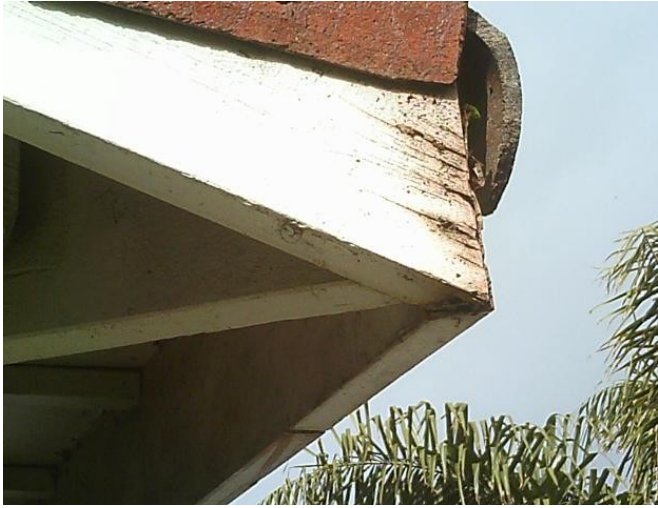
Picture 1

1A. FINDING: Fungus damage was noted to the barge rafter and fascia as indicated on the diagram. (See Picture 1)

RECOMMENDATION: Remove and replace the entire wood members to correct this condition. This bid includes replacement of the roof covering if disturbed by our repairs. If existing gutters need to be removed to perform the repairs then our bid also includes reinstallation of original gutters. If it becomes necessary or desirable to install new gutters this will be done only if authorized and at an additional cost. The guarantees on the roof covering are limited to the areas where the work was performed

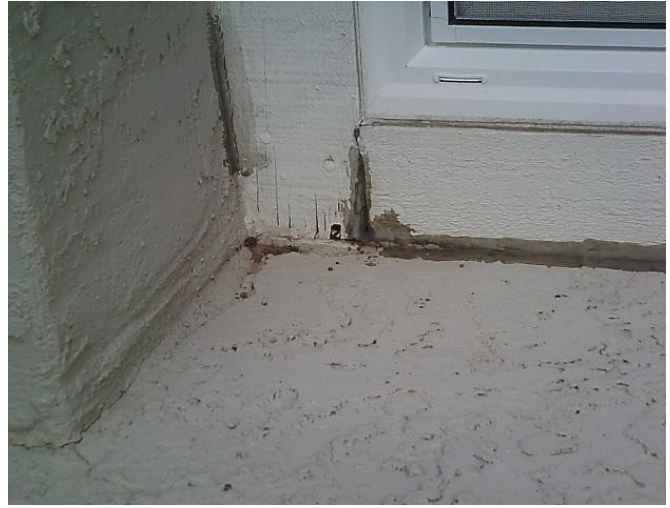
Picture 2

1B. FINDING: The trim has been damaged by fungus at the front and rear window. (See Picture 2)

RECOMMENDATION: Remove and replace all the damaged wood members. If any damage is found to extend into any enclosed areas a supplemental report and bid will be issued.

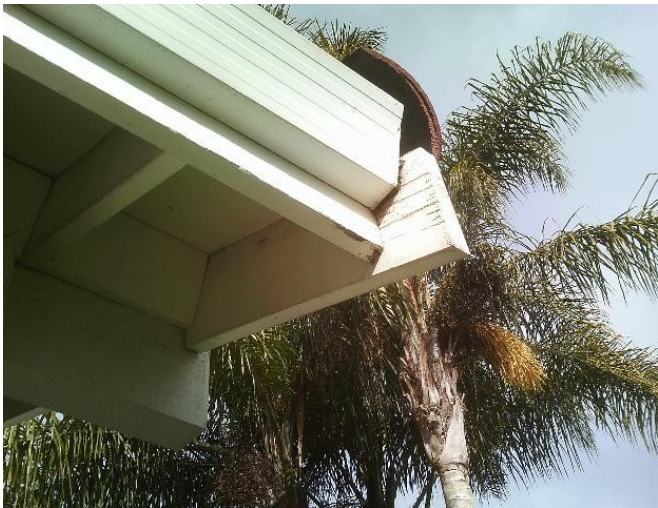
Picture 3

1C. FINDING: Fungus damage was noted to the fascia as indicated on the diagram. (See Picture 3)

RECOMMENDATION: Remove and replace the damaged wood members to correct this condition. This bid includes replacement of the roof covering if disturbed by our repairs. If existing gutters need to be removed to perform the repairs then our bid also includes reinstallation of original gutters. If it becomes necessary or desirable to install new gutters this will be done only if authorized and at an additional cost. The guarantees on the roof covering are limited to the areas where the work was performed

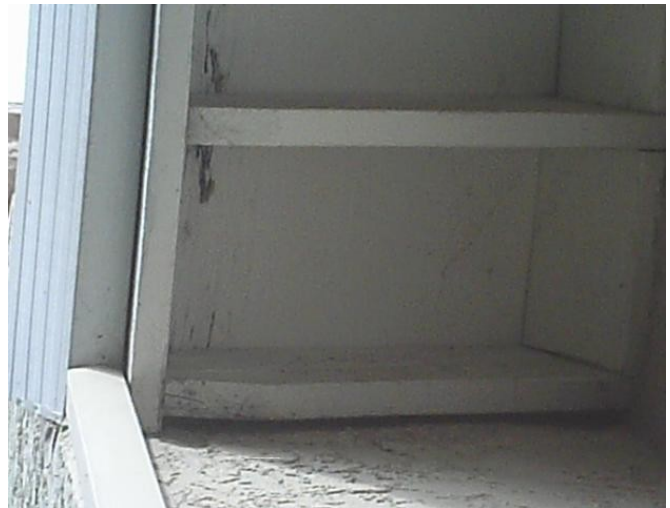
Picture 4

1D. FINDING: Fungus damage was noted to the second story roof eaves as indicated on the diagram. (See Picture 4)

1E. FINDING: The jamb and trim have been damaged by fungus at the main garage door. (See Picture 4)

RECOMMENDATION: Remove and replace the damaged wood members to correct this condition. This bid includes replacement of the roof covering if disturbed by our repairs. If existing gutters need to be removed to perform the repairs then our bid also includes reinstallation of original gutters. If it becomes necessary or desirable to install new gutters this will be done only if authorized and at an additional cost. The guarantees on the roof covering are limited to the areas where the work was performed

RECOMMENDATION: Remove and replace all the damaged wood members. If any damage is found to extend into any enclosed areas a supplemental report and bid will be issued.

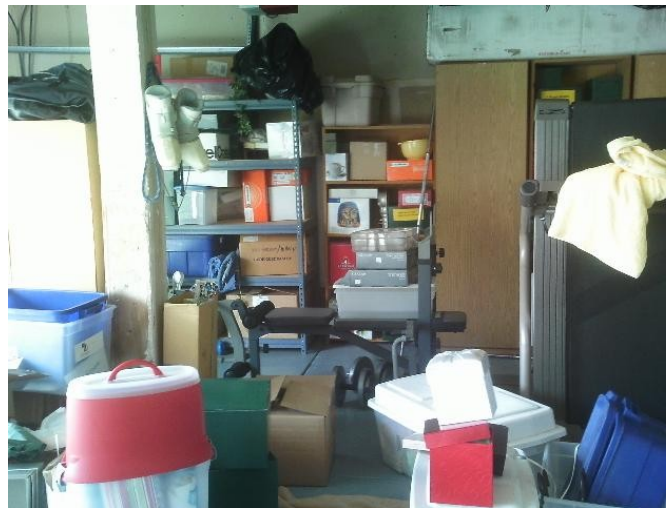
Picture 7

3B. FINDING: We were unable to inspect the interior of the garage due to stored personal property. (See Picture 7)
RECOMMENDATION: The owner should move the storage away from the garage walls to allow for further inspection. All findings, recommendations, and bids will be issued in a supplemental report.
***** (FURTHER INSP ITEM) *****

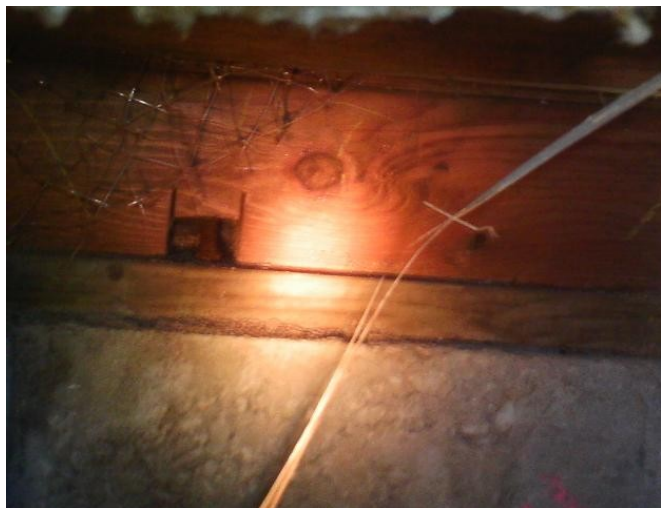
Picture 8

1G. FINDING: Infestation by Drywood Termites was noted at the subarea. (See Picture 8)

1H. FINDING: Drywood termite pellets were evident as noted in the above recommendation. (See Picture 8)

RECOMMENDATION: Due to the nature of these infestations, it will be necessary to seal the entire structure and fumigate it with Vikane (sulfuryl fluoride), using Chloropicrin as a warning agent. The entire structure must be vacant for this process. It is the owners responsibility to make any preparations required by the fumigators or to have someone to do so at a separate expense and to have the gas turned back on when the fumigation is complete. Due to current Cal OSHA Safety Standards work above 7.5 feet demands fall protection, this requires the installation of anchor points at the roof ridge line. HomeGuard will repair any damage caused by the installation of the anchor. However, in the case of metal roof coverings it is the owners responsibility to make areas on the roof ridge accessible to secure the anchors. HomeGuard Incorporated guarantees all fumigations for a period of two years.

RECOMMENDATION: Remove and/or mask over all accessible termite pellets. It is possible for the Drywood Termite pellets to sift down or reappear in these areas where they have been masked over.
