Property Inspection Report

627 Cayuga Drive, San Jose, CA 95123

Robert Ripke
April 29, 2010
Report No. 141469

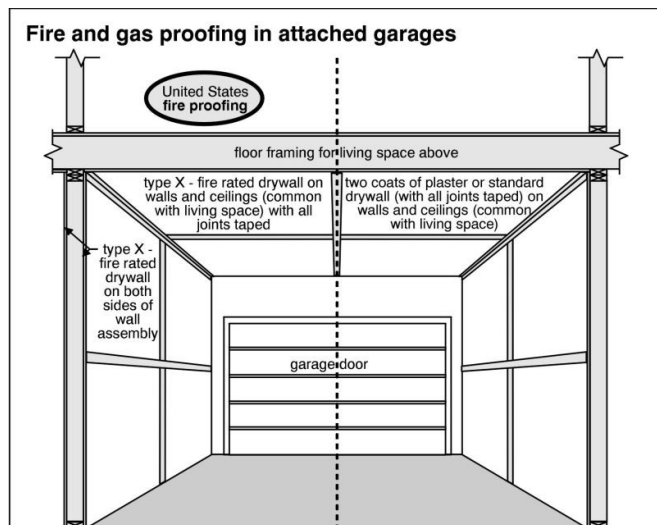
Illustration 3A

- ! 1. Damaged, open or missing wall and/or ceiling finishes of attached garages at the laundry should be repaired and sealed where they abut the interior of a house. This reduces the potential of toxic automobile gases entering the house and serves as a fire break. Current standards require all walls/ceilings common to the finished living spaces be covered with 5/8" fire resistant sheetrock, double taped at all seams. (See Illustration 3A) (See Picture 2)

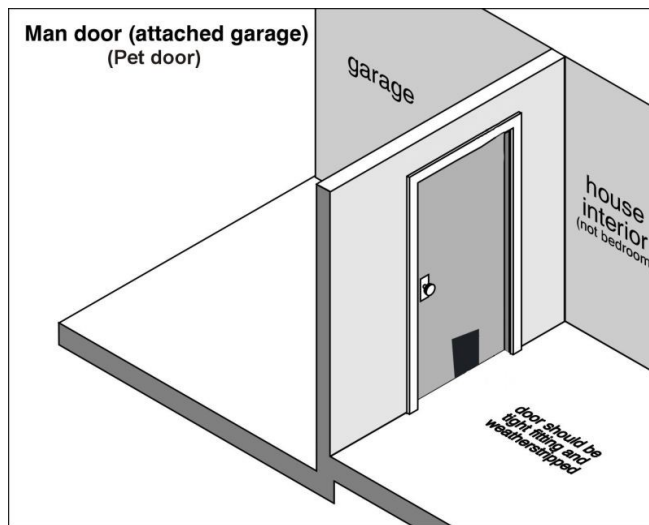
Illustration 6C

- ! 2. The pet door within the garage passage door is a breach in the fire separation between the garage and the living area. The opening is near the floor and may not significantly increase the risk of fire spreading. However, we recommend replacement if the pet door is not used. (See Illustration 6C) (See Picture 3)

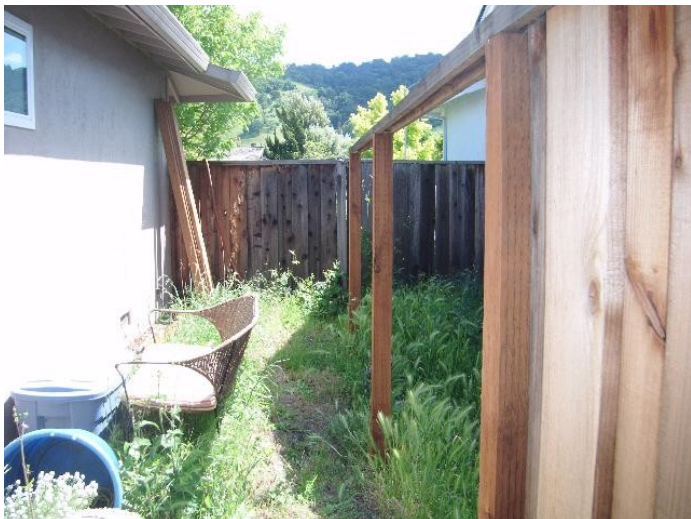
Picture 1

- 6. There is no fencing at the left side of the structure. We recommend all sections of missing fence be replaced. (See Picture 1)

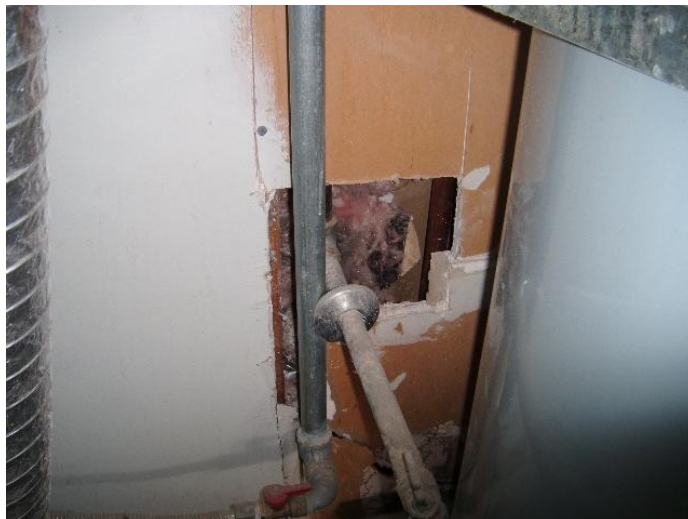
Picture 2

4. Damaged, open or missing wall and/or ceiling finishes of attached garages at the laundry should be repaired and sealed where they abut the interior of a house. This reduces the potential of toxic automobile gases entering the house and serves as a fire break. Current standards require all walls/ceilings common to the finished living spaces be covered with 5/8" fire resistant sheetrock, double taped at all seams. (See Illustration 3A) (See Picture 2)

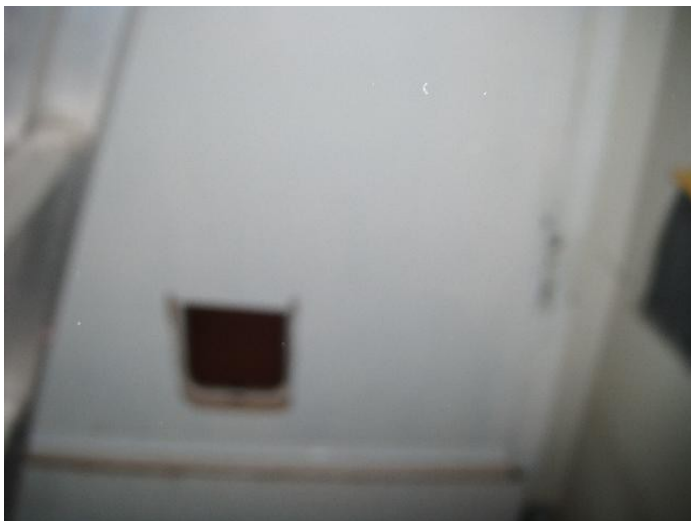
Picture 3

5. The pet door within the garage passage door is a breach in the fire separation between the garage and the living area. The opening is near the floor and may not significantly increase the risk of fire spreading. However, we recommend replacement if the pet door is not used. (See Illustration 6C) (See Picture 3)

- ! 1. The master bathroom shower faucet hot and cold water controls are reversed. Reversed hot and cold water can result in hot water burns. We recommend that this condition be corrected.
2. There is evidence of heavy corrosion and rust, but no leakage on the exterior of the exposed and accessible metal supply piping in the crawl space. This piping should be monitored for leakage and repaired as necessary. Upgrading this piping and connections should also be considered. (See Picture 3)

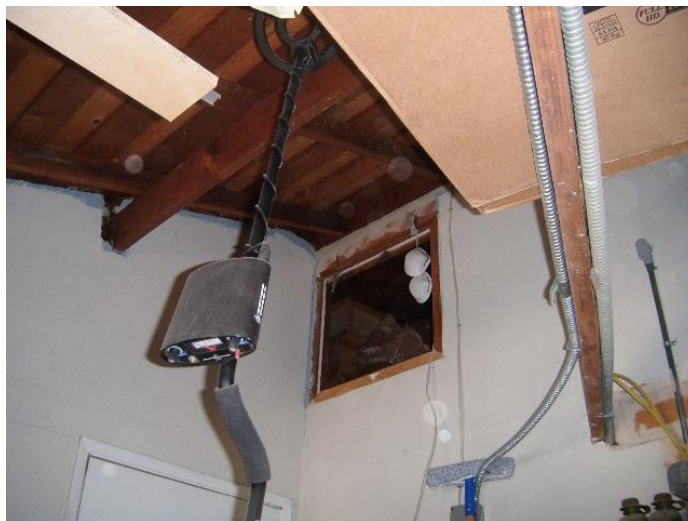
Picture 5

1. The access to the attic in the garage is missing and open. This condition could lead to a more rapid spread of smoke and flames in a fire. We recommend covering the access into the attic with a removable panel of plywood or drywall in accordance with present standards. (See Picture 5)

- ! 2. The access to the attic in the garage is missing and open. This condition could lead to a more rapid spread of smoke and flames in a fire. We recommend covering the access into the attic with a removable panel of plywood or drywall in accordance with present standards. (See Picture 5)
