Roof Inspection Report

627 Cayuga Drive, San Jose

**Ernest (Andy) Rodriguez
April 29, 2010
Report No. 141469**

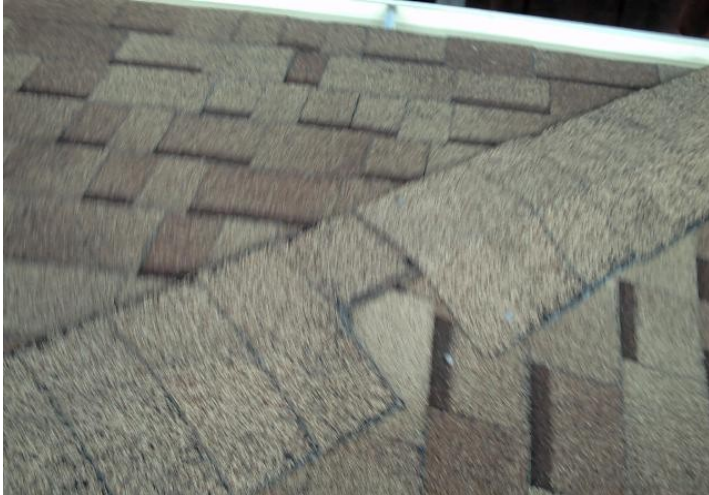
Picture 1

1. There are missing and/or degranulated ridge caps. (See Picture 1)

Repair and/or replace all missing and/or degranulated ridge caps as needed.

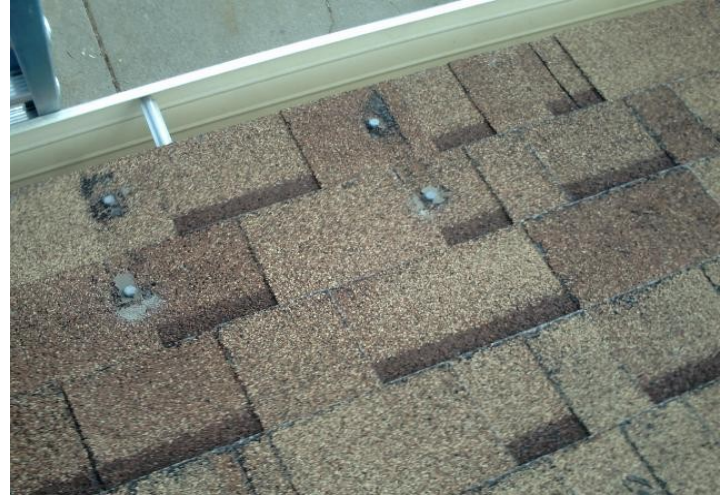
Picture 2

2. There is evidence that a unknown item was installed directly onto the roof covering, when removed the bolt hole(s) were not sealed properly to prevent leakage. (See Picture 2)

Seal the bolt hole(s) as necessary to prevent leakage.

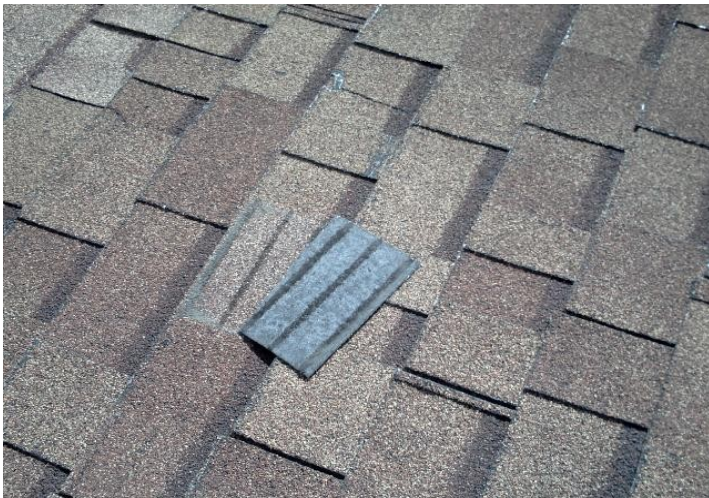
Picture 3

3. There are degranulated, broken, ripped, missing and/or loose shingles in the field. (See Picture 3) (See Picture 4) (See Picture 8) (See Picture 15) (See Picture 16)

Replace and/or repair all degranulated, broken, ripped, missing and/or loose shingles in the field as needed.

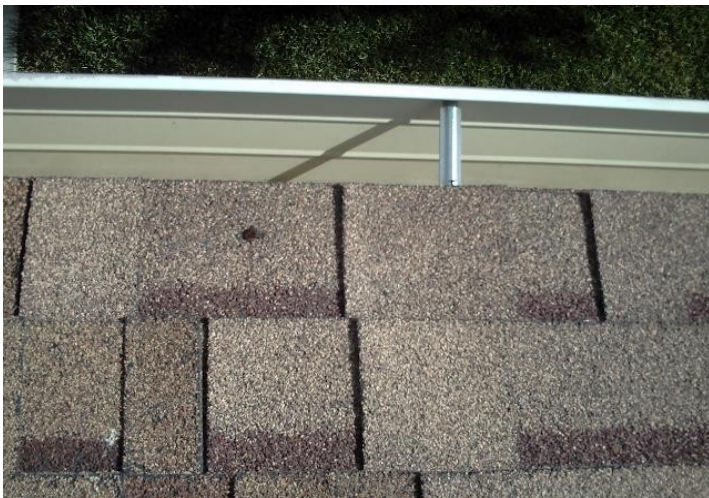
Picture 5

4. There are isolated areas where the fasteners used to secure the shingles have come loose and are working their way through the shingles. (See Picture 5) (See Picture 14)

Secure shingles where fasteners have penetrated through and seal as necessary.

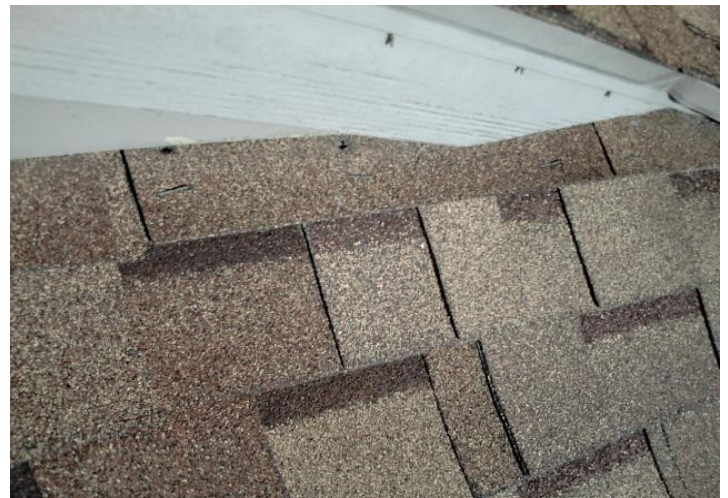
Picture 6

5. There are exposed fasteners in the field that may leak if not sealed. (See Picture 6)

Seal any exposed fasteners in the field.

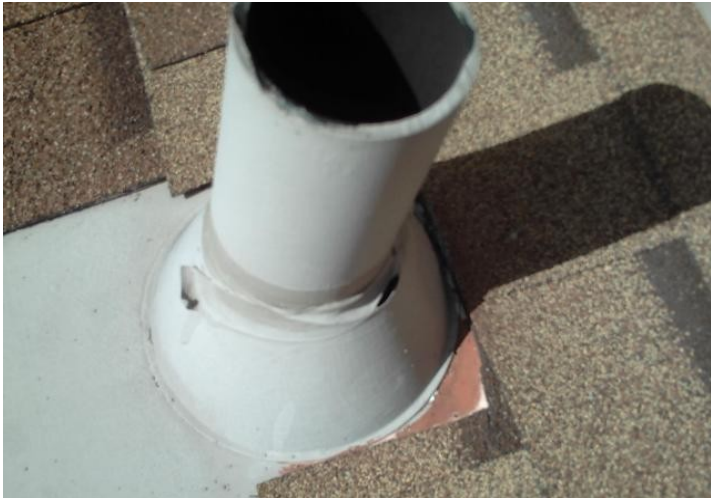
Picture 7

6. The plumbing jack flashing is not sealed properly at the collars. (See Picture 7) (See Picture 13)

Seal all plumbing vent collars as needed.

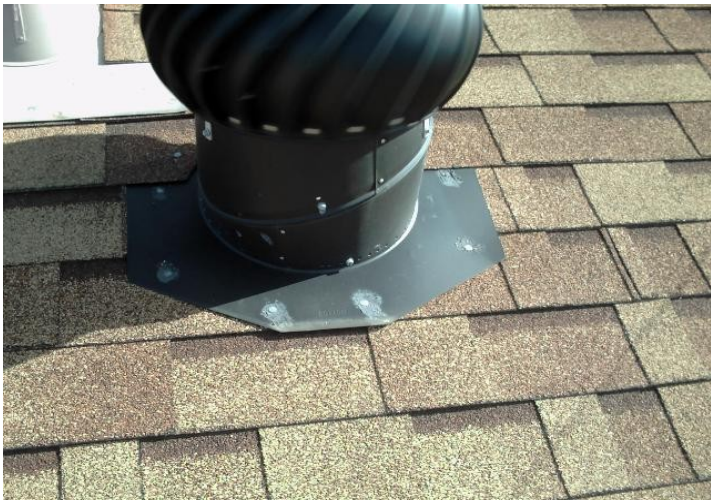
Picture 9

7. Two turbine vent flashings are not properly integrated into the roofing system. The water shedding ability of this area cannot be guaranteed. (See Picture 9) (See Picture 12)

Properly integrate the two turbine vent flashings into the roof system as needed to ensure a water impermeable condition.

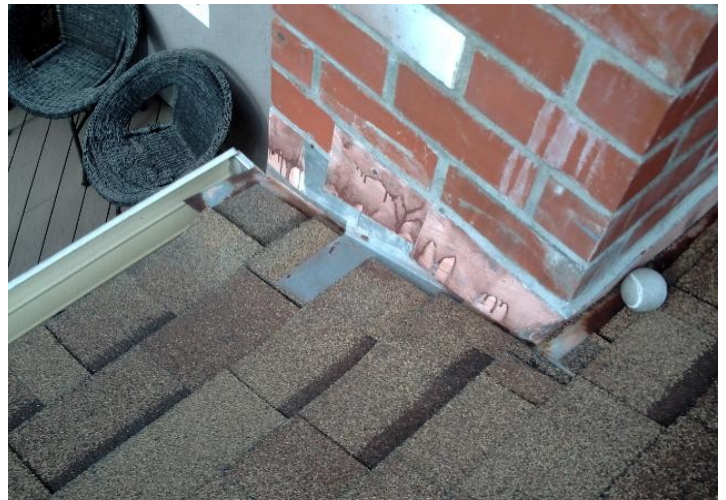
Picture 10

8. The chimney flashing is not properly secured and is pulling up and away from the roof's surface. (See Picture 10) (See Picture 11)

Secure the chimney flashing as necessary to make watertight.

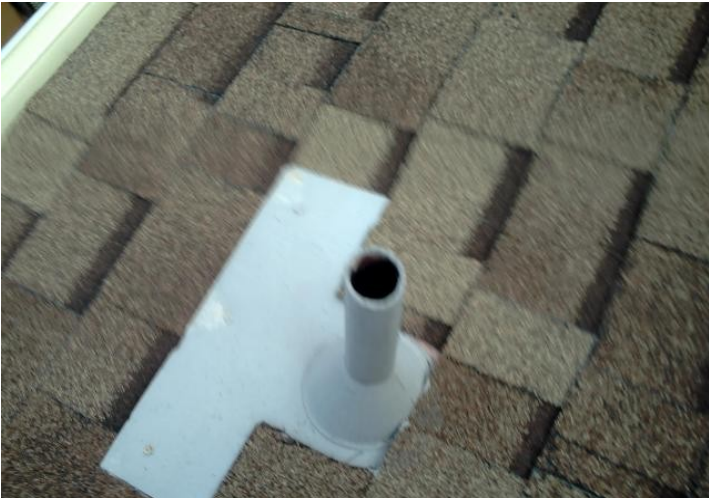
Picture 13

9. The roof to wall undershot(s) is lacking a proper seal, subsequently wind driven water may enter beneath the roofing system. (See Picture 13) (See Picture 14)

Seal the roof to wall undershot(s) as necessary to ensure a water-tight condition.
