WOOD DESTROYING PESTS AND ORGANISM INSPECTION REPORT

Building No. 627	Street Cayuga Drive	City San Jose	ZIP 95123	Date of Inspection 4/29/2010	Number of Pages Page 1 of 8
----------------------------	-------------------------------	-------------------------	---------------------	--	---------------------------------------

HomeGuard Rpt #: **141469**

General Description: One story, single family wood framed residence with wood, stucco and brick exterior. Limited to the main structure only, excluding the deck.	Inspection Tag Posted: Garage
	Other Tags Posted: None noted

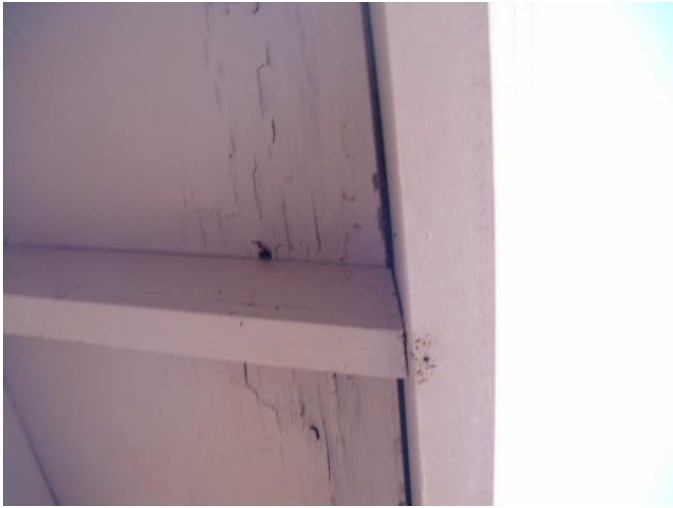
Picture 1

1A. FINDING: Fungus damage was noted to the roof eaves as indicated on the diagram. (See Picture 1)

RECOMMENDATION: Remove and replace the damaged wood members to correct this condition. This bid includes replacement of the roof covering if disturbed by our repairs. If existing gutters need to be removed to perform the repairs then our bid also includes reinstallation of original gutters. If it becomes necessary or desirable to install new gutters this will be done only if authorized and at an additional cost. The guarantees on the roof covering are limited to the areas where the work was performed

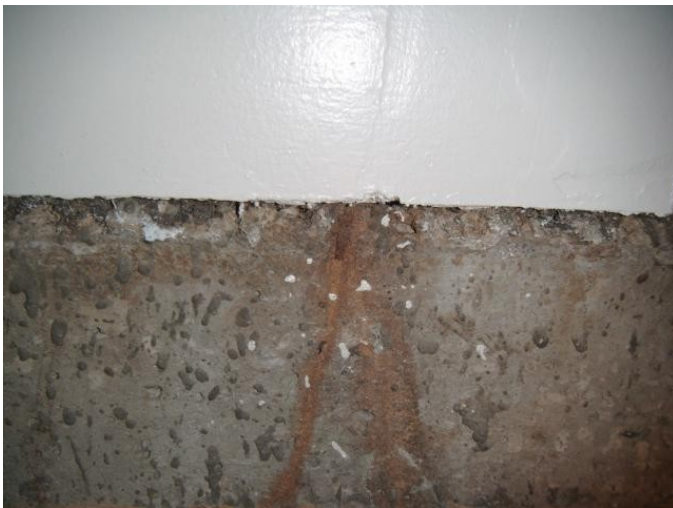
Picture 2

1B. FINDING: Subterranean Termites have entered the structure from the earth fill under the garage slab and in the subarea adjacent to the garage. (See Picture 2) (See Picture 6)

1C. FINDING: There is evidence of Subterranean Termite migratory tubes as noted in the above recommendation. (See Picture 2) (See Picture 6)

RECOMMENDATION: Drill holes through the garage slab and inject Termidor SC (Fipronil:5-amino-1-(2,6-dichloro-4-(trifluoromethyl) phenyl)-4-((1,8,5)-trifluoromethyl)sulfinyl)-1-H-pyrazole-3-carbonitrile) into the earth below. We will be as careful as possible with our repair; however, we assume no responsibility for any damage to the surface covering the floor in the area to be treated. **NOTE:** In order to perform this treatment the property will need to be vacated for the period during and 3 hours after the treatment is performed.

RECOMMENDATION: Break down & brush away all termite migratory tubes.

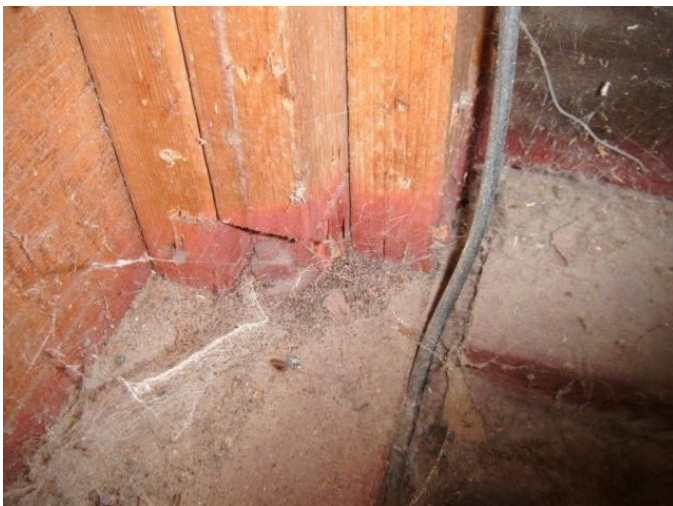
Picture 3

1D. FINDING: Infestation by Drywood Termites was noted at the garage and subarea. (See Picture 3)

1E. FINDING: Drywood termite pellets were evident as noted in the above recommendation. (See Picture 3)

1G. FINDING: The wall stud has been damaged by drywood termites at the garage. (See Picture 3)

RECOMMENDATION: Due to the nature of these infestations, it will be necessary to seal the entire structure and fumigate it with Vikane (sulfuryl fluoride), using Chloropicrin as a warning agent. The entire structure must be vacant for this process. It is the owners responsibility to make any preparations required by the fumigators or to have someone to do so at a separate expense and to have the gas turned back on when the fumigation is complete. Due to current Cal OSHA Safety Standards work above 7.5 feet demands fall protection, this requires the installation of anchor points at the roof ridge line. HomeGuard will repair any damage caused by the installation of the anchor. However, in the case of metal roof coverings it is the owners responsibility to make areas on the roof ridge accessible to secure the anchors. HomeGuard Incorporated guarantees all fumigations for a period of two years.

RECOMMENDATION: Remove and/or mask over all accessible termite pellets. It is possible for the Drywood Termite pellets to sift down or reappear in these areas where they have been masked over.

RECOMMENDATION: Remove and replace all the damaged wood members. If any damage is found to extend into any enclosed areas a supplemental report and bid will be issued.

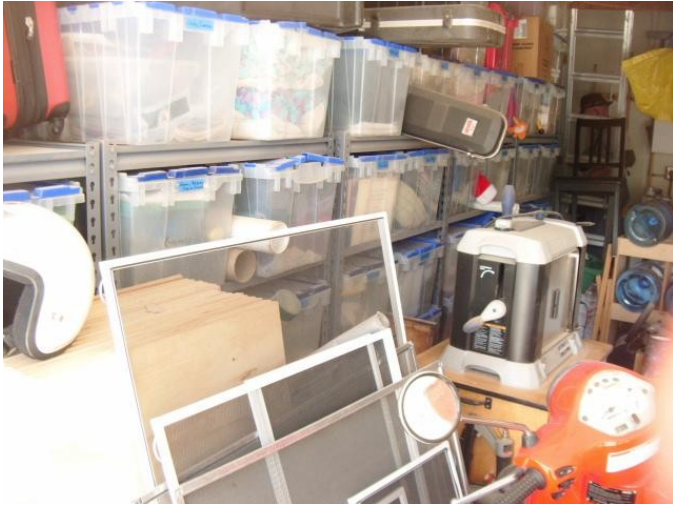
Picture 4

1F. FINDING: We were unable to inspect the interior of the garage due to stored personal property and drywood termites and subterranean termites were noted. (See Picture 4)

RECOMMENDATION: The owner should move the storage away from the garage walls to allow for further inspection. All findings, recommendations, and bids will be issued in a supplemental report.

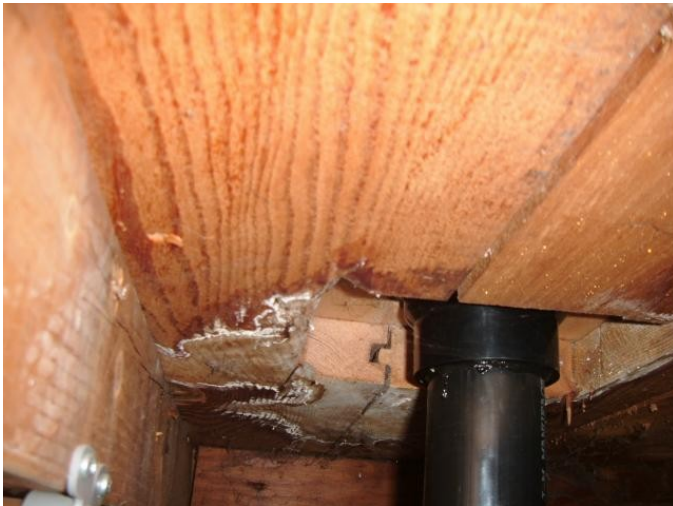
Picture 5

1H. FINDING: There is a surface fungus condition located under the bathroom at the subarea. (See Picture 5)

RECOMMENDATION: Scrape or wire brush this area and treat with a registered fungicide Timbor (Disodium Octoborate Tetrahydrate). NOTE: In order to perform this treatment the property will need to be vacated during and 3 hours after the treatment is performed.
