Property Inspection Report

1071 Belder Drive, San Jose, CA 95120

Robert Scott Ripke
July 21, 2011
Report No. 152045

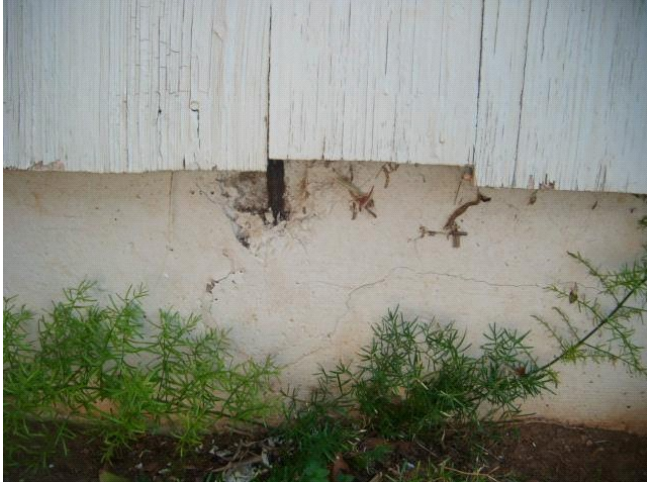
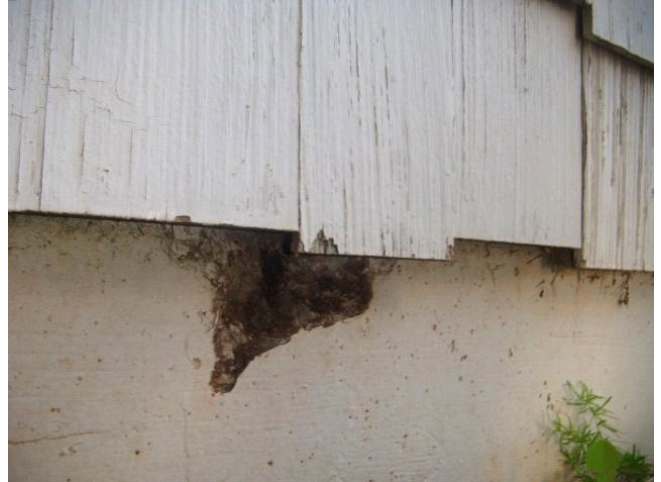
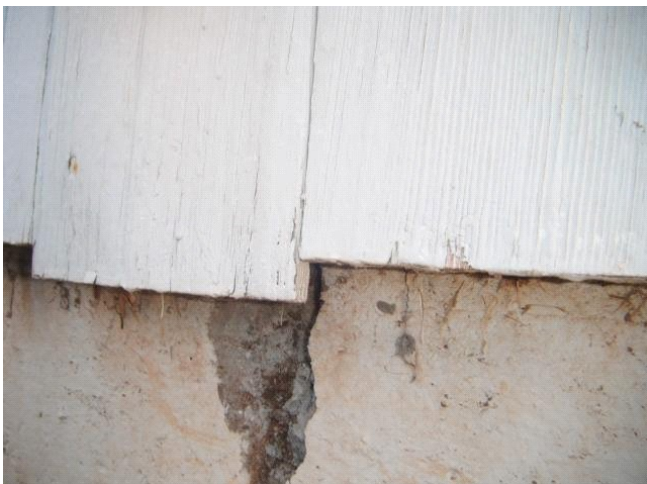
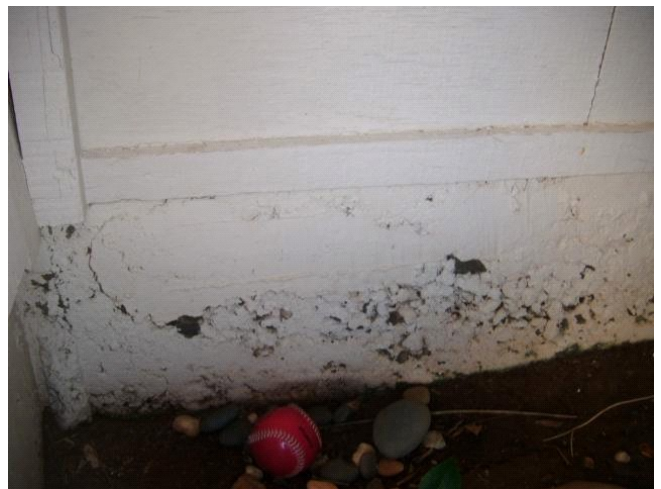
2. There is exposed reinforcing steel or anchor bolt at the front exterior of the foundation as noted from the crawl space. We recommend all exposed steel be covered with material such as epoxy to prevent rust and subsequent foundation damage. (See Picture 10) (See Picture 1) (See Picture 2) (See Picture 5)

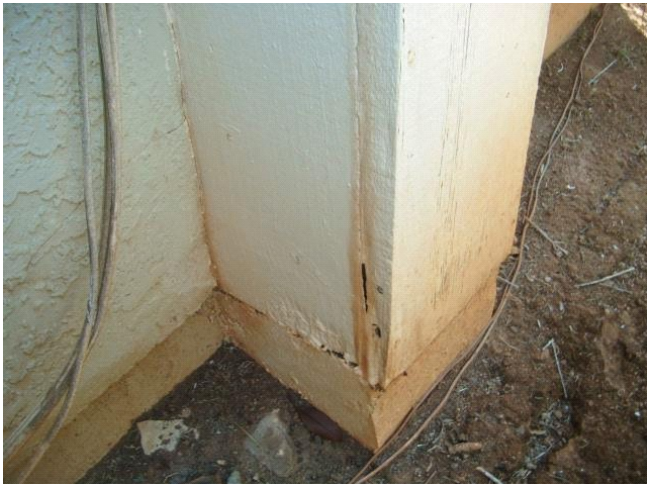
Picture 3

2. Water damage was observed to the exterior trim at various areas. We recommend further investigation and repair by the appropriate trades. (See Picture 3)
3. Water damage was observed to the rafters at various areas. We recommend the advice and services of a licensed general contractor and/or structural pest control company regarding repairs. (See Picture 6)
4. Water damage was observed to the wood siding in the exterior walls. We recommend the advice and services of a licensed general contractor and/or structural pest control company. (See Picture 7)
5. Damage was observed in the planter shelf. We recommend the advice and services of the appropriate trades regarding repairs to this area. (See Picture 4)

- ! 5. Water damage was observed to the exterior trim at various areas. We recommend further investigation and repair by the appropriate trades. (See Picture 3)

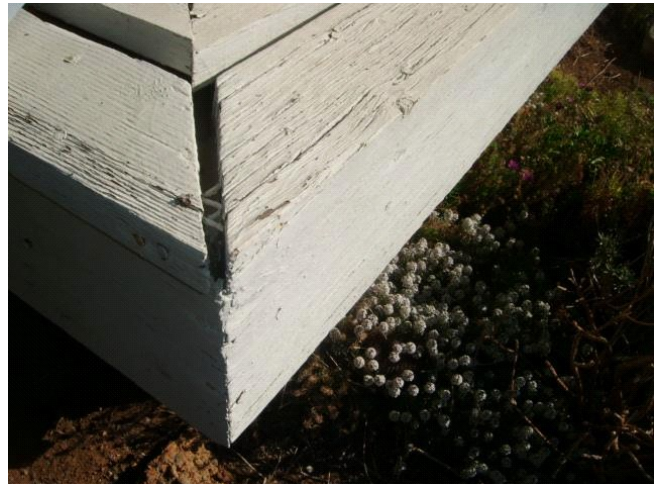
Picture 4

- ! 6. Damage was observed in the planter shelf. We recommend the advice and services of the appropriate trades regarding repairs to this area. (See Picture 4)

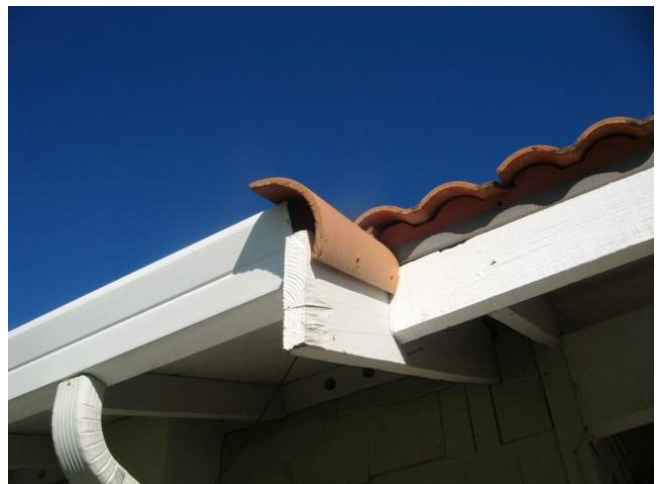
Picture 6

- ! 2. Water damage was observed to the rafters at various areas. We recommend the advice and services of a licensed general contractor and/or structural pest control company regarding repairs. (See Picture 6)

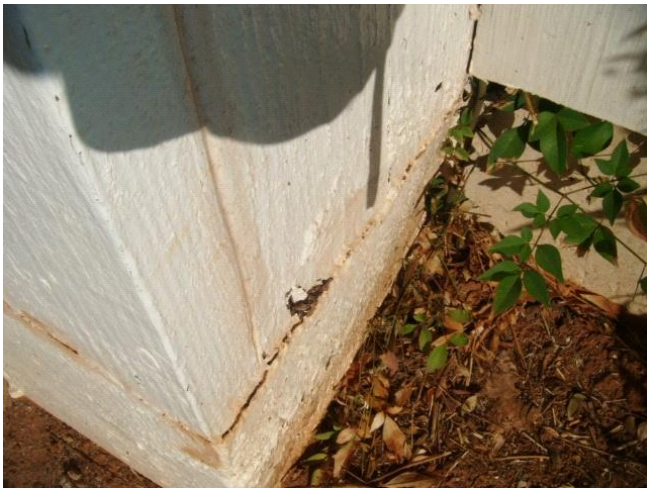
Picture 7

- ! 3. Water damage was observed to the wood siding in the exterior walls. We recommend the advice and services of a licensed general contractor and/or structural pest control company. (See Picture 7)

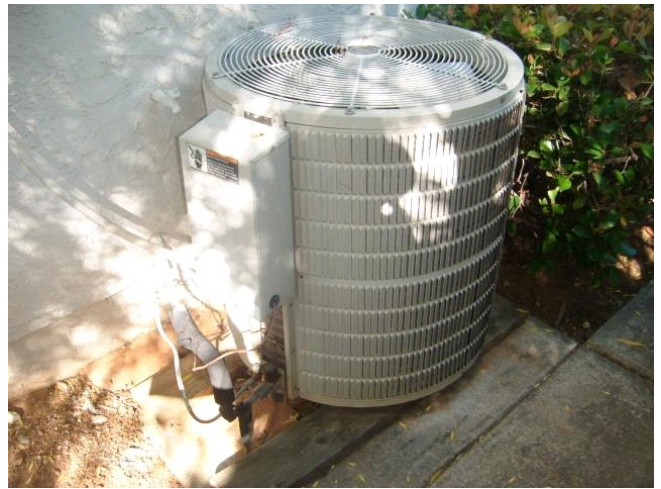
Picture 8

1. Damaged insulation on air conditioner refrigerant lines should be repaired. This will help to increase the efficiency of the unit. (See Picture 8)
2. The data plate on the cooling system was not visible/legible at the time of this inspection. (See Picture 8)
3. The air conditioning unit is not mounted or secured to the platform properly. We recommend it be secured or mounted as necessary. (See Picture 8)

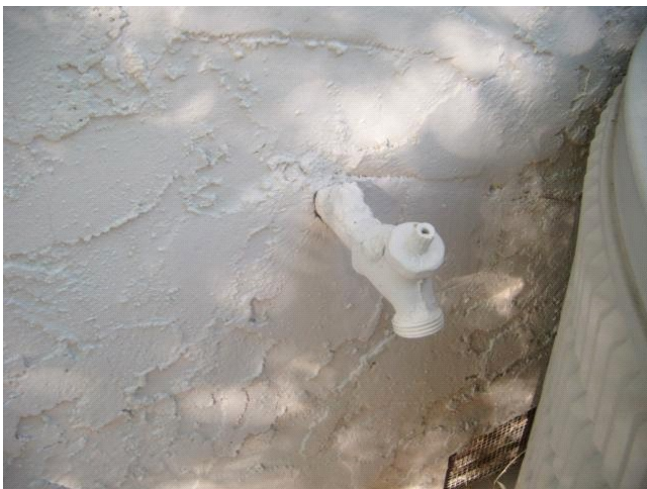
Picture 9

1. There is evidence of past leaks and corrosion but no active leakage was noted to the exterior of the kitchen sink and drain piping. This area should be monitored for leakage and repaired as necessary. Upgrading this piping and connections should also be considered.
2. The exterior hose bib handle at the right side faucet is missing. We recommend it be replaced for full use of this area. (See Picture 9)

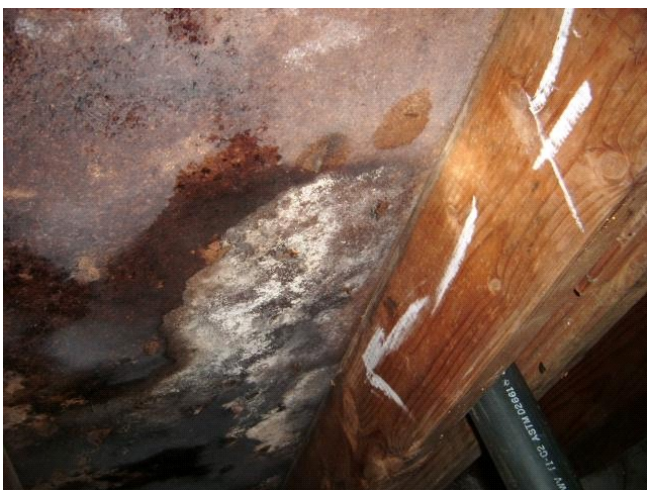
Picture 11

1. The wood members under the hall bathroom show evidence of water damage. We recommend the advice and services of a licensed structural pest control operator for investigation and repair of this condition. (See Picture 11)

- ! 5. The wood members under the hall bathroom show evidence of water damage. We recommend the advice and services of a licensed structural pest control operator for investigation and repair of this condition. (See Picture 11)
