WOOD DESTROYING PESTS AND ORGANISM INSPECTION REPORT

Building No. 1071	Street Belder Drive	City San Jose	ZIP 95120	Date of Inspection 7/21/2011	Number of Pages Page 1 of 8
-----------------------------	-------------------------------	-------------------------	---------------------	--	---------------------------------------

HomeGuard Rpt #: **152045**

General Description: One story, single family wood framed residence with wood and stucco exterior.	Inspection Tag Posted: Garage Other Tags Posted: None noted
---	--

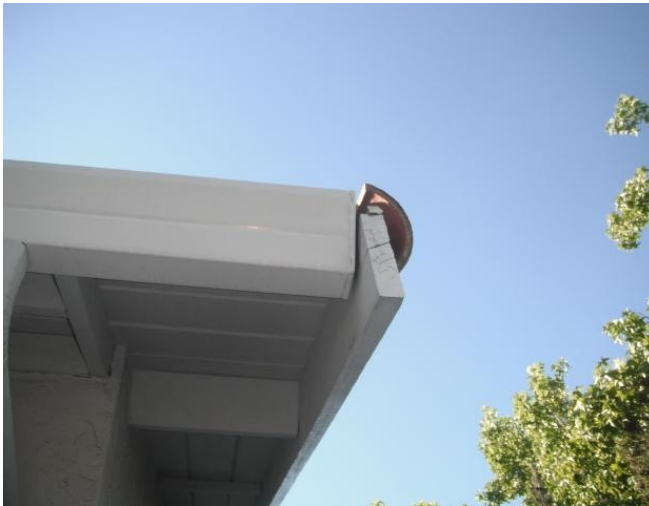
Picture 1

1A. FINDING: Fungus damage was noted to the rafter tail ends at the rear. (See Picture 1)

RECOMMENDATION: Cut off and omit approximately 2-3 inches from all of the rafter tail ends in this area, and dispose of same. Paint end of rafters with one coat of primer or one coat of color provided by owner.

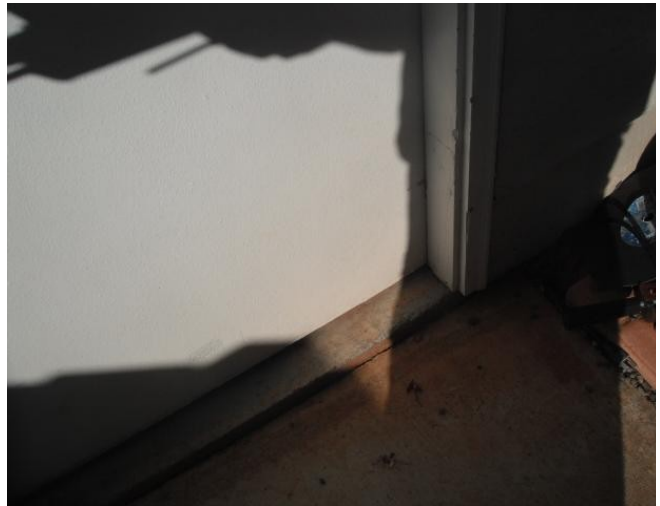
Picture 2

1B. FINDING: The side garage entry door jambs are fungus damaged. (See Picture 2)

RECOMMENDATION: Cut off the bottom of the door jambs and fill the void with concrete.

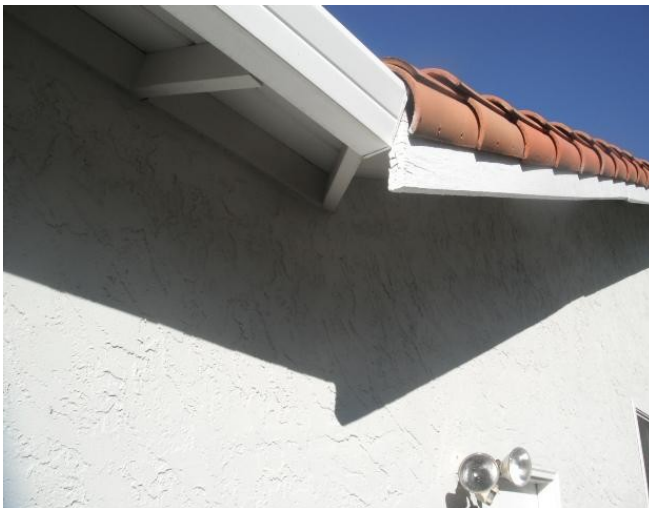
Picture 3

1C. FINDING: Fungus damage was noted to the barge rafter(s) as indicated on the diagram. (See Picture 3)

RECOMMENDATION: Remove and replace a section of the damaged barge(s) rafter to correct this condition. This bid includes replacement of the roof covering if disturbed by our repairs. If existing gutters need to be removed to perform the repairs then our bid also includes reinstallation of original gutters. If it becomes necessary or desirable to install new gutters this will be done only if authorized and at an additional cost. The guarantees on the roof covering are limited to the areas where the work was performed

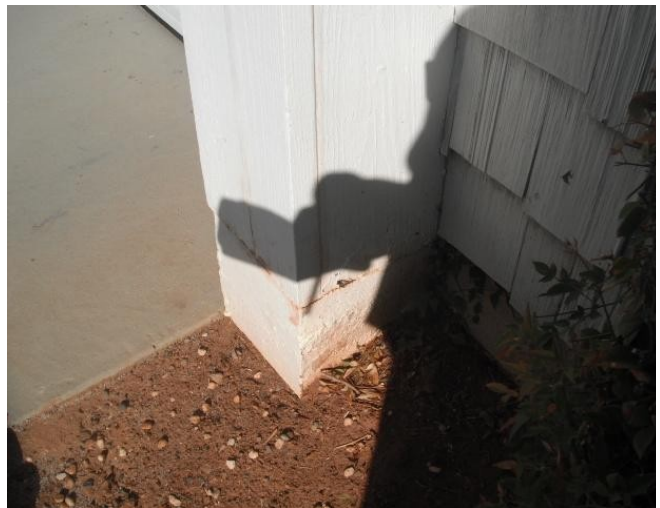
Picture 4

1D. FINDING: The trim has been damaged by drywood termite at the garage abutment. (See Picture 4)

1F. FINDING: The trim has been damaged by fungus at the left abutment. (See Picture 4)
RECOMMENDATION: Remove and replace all the damaged wood members. If any damage is found to extend into any enclosed areas a supplemental report and bid will be issued.
***** (SECTION 1 ITEM) *****

RECOMMENDATION: Remove and replace all the damaged wood members. If any damage is found to extend into any enclosed areas a supplemental report and bid will be issued.

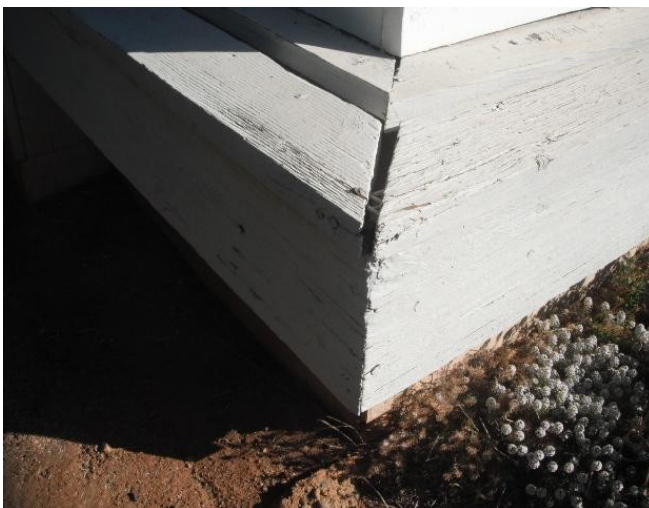
Picture 5

1E. FINDING: The shelf has been damaged by fungus at the front. (See Picture 5)

RECOMMENDATION: Remove and replace all the damaged wood members. If any damage is found to extend into any enclosed areas a supplemental report and bid will be issued.

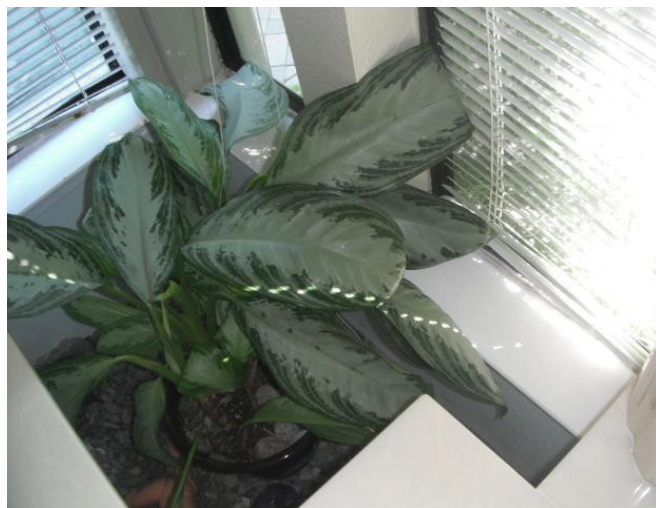
Picture 7

1G. FINDING: The window sill at the master bathroom was found to be damaged by fungus. (See Picture 7)
RECOMMENDATION: Remove and replace the damaged window sill to correct this condition.
***** (SECTION 1 ITEM) *****
