Property Inspection Report

3280 Julio Avenue, San Jose, CA 95124

Robert Ripke
May 24, 2011
Report No. 150598

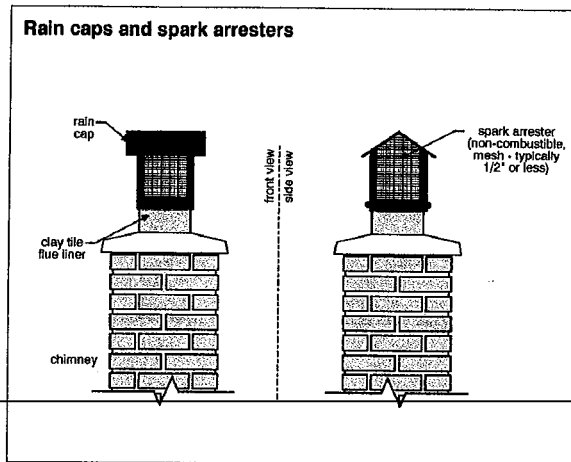
Illustration 3I

1. The chimney does not have a spark arrester or rain cap. A rain cap and/or screen should be installed on the masonry chimney. (See Illustration 3I) (See Picture 3)
- ! 2. The built-up/flat roofing over the patio room is past the end of its life cycle and should be replaced. There is significant deterioration throughout the field. It is recommended that roofing materials be removed prior to re-roofing. When re-roofing, it is recommended that all flashing be replaced at that time. For further evaluation of the condition of the roof we recommend you consult a licensed roofing contractor. (See Picture 1)

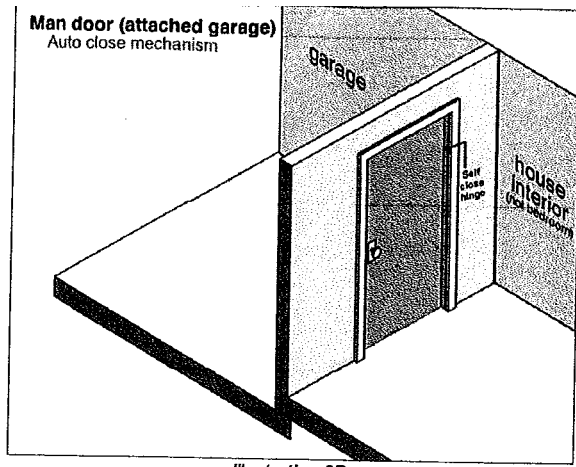
Illustration 6B

6. The door between the garage and the interior of the house should be fitted with an automatic closer mechanism. This will reduce the potential of toxic automobile gases entering the house and serves as a fire break. (See Illustration 6B)

- ! 1. Cracked or broken window's glass at the middle bedroom should be replaced. (See Picture 20) (See Picture 21)
- ! 2. The door between the garage and the interior of the house should be fitted with an automatic closer mechanism. This will reduce the potential of toxic automobile gases entering the house and serves as a fire break. (See Illustration 6B)

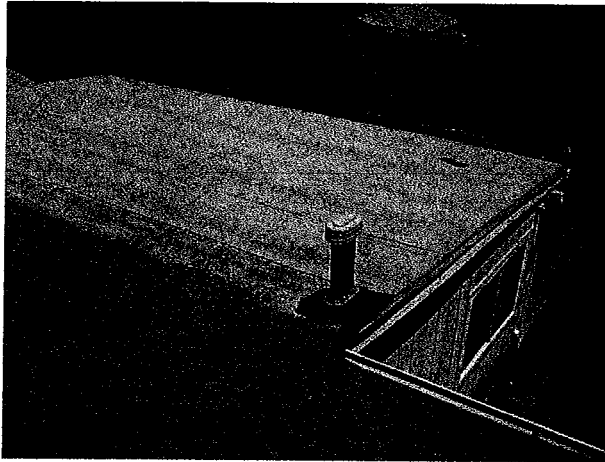
Picture 1

1. The built-up/flat roofing over the patio room is past the end of its life cycle and should be replaced. There is significant deterioration throughout the field. It is recommended that roofing materials be removed prior to re-roofing. When re-roofing, it is recommended that all flashing be replaced at that time. For further evaluation of the condition of the roof we recommend you consult a licensed roofing contractor. (See Picture 1)

4. Water damage was observed to the front and rear beam ends. We recommend the damaged wood members be repaired or replaced as necessary. (See Picture 1) (See Picture 2) (See Picture 4) (See Picture 5)

- ! 7. Water damage was observed to the front and rear beam ends. We recommend the damaged wood members be repaired or replaced as necessary. (See Picture 1) (See Picture 2) (See Picture 4) (See Picture 5)

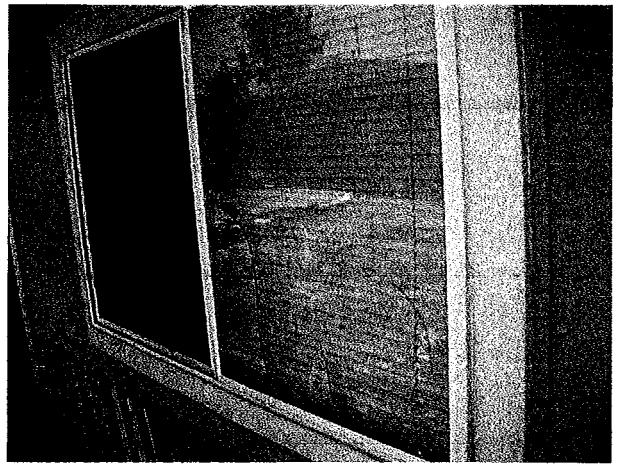
Picture 8

5. Water damage was observed to the wood siding in the exterior walls by the rear patio room. We recommend the advice and services of a licensed general contractor and/or structural pest control company. (See Picture 8)

- ! 6. Water damage was observed to the wood siding in the exterior walls by the rear patio room. We recommend the advice and services of a licensed general contractor and/or structural pest control company. (See Picture 8)

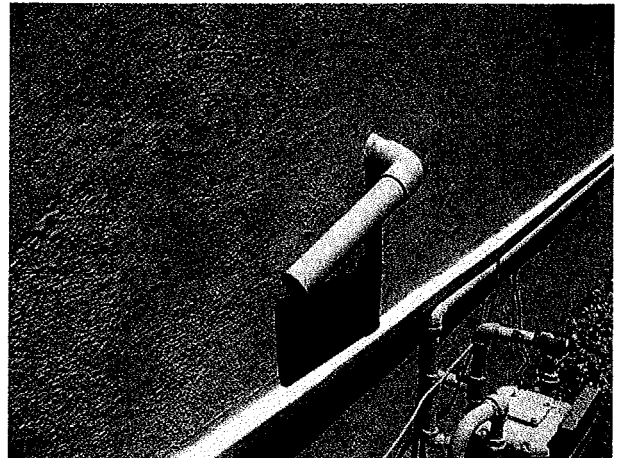
Picture 10

10. The clean out cap is missing at the right. We recommend replacing the cap to prevent sewage spillage and odor. (See Picture 10)
11. The water heater vent pipe or hood is loose and exhaust leakage was evident. This is a potential safety concern that should be addressed. We recommend the vent and hood be properly installed as necessary. (See Picture 14)

- ! 1. The clean out cap is missing at the right. We recommend replacing the cap to prevent sewage spillage and odor. (See Picture 10)
- ! 2. The water heater vent pipe or hood is loose and exhaust leakage was evident. This is a potential safety concern that should be addressed. We recommend the vent and hood be properly installed as necessary. (See Picture 14)

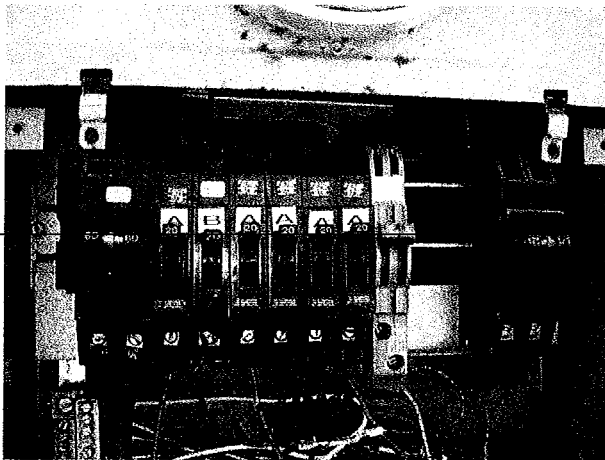
Picture 11

3. One or more of the circuit breakers within the main electrical panel are not of the same manufacture as the panel. Due to the age of the panel, original manufacture circuit breakers may not be readily available. Since no obvious conditions are noted in regards to this condition replacement would be optional. (See Picture 11)

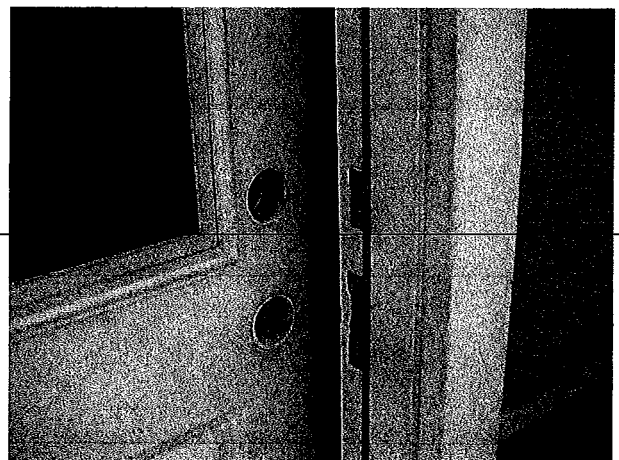
Picture 12

8. One or more of the exterior garage passage doors have missing hardware. We recommend that hinges, knobs, latches and strike plates be adjusted or replaced to restore full operation. (See Picture 12)

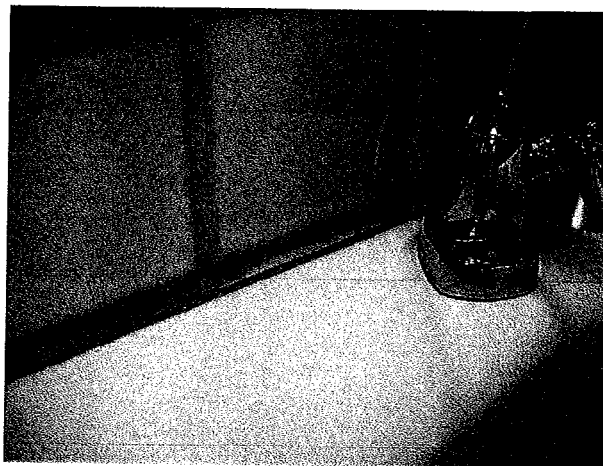
Picture 16

- ! 4. The kitchen countertop is water damaged in the areas under and around the sink where water leakage has occurred. We recommend the advice and services of a licensed structural pest control operator for investigation and repair of this condition. (See Picture 15)
5. Cracked, deteriorated and/or missing caulk at the kitchen countertop backsplash should be replaced. A flexible caulking material is recommended rather than rigid cementitious grout. (See Picture 16)

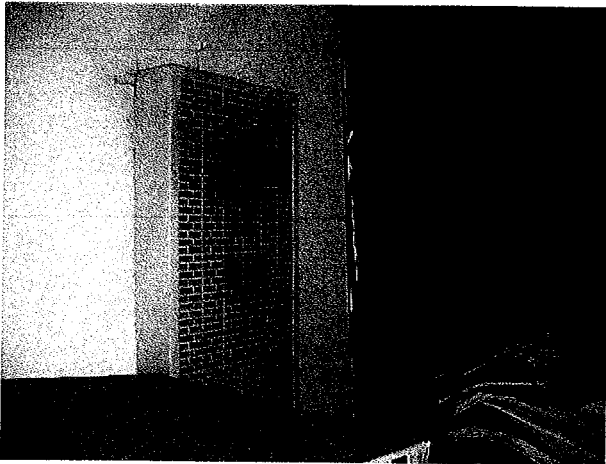
Picture 19

Due to owner furniture or storage, inspection of the heating unit in the patio room was restricted. We recommend inspection of the heater components when access is provided. For additional information we recommend the services of a licensed heating contractor. (See Picture 19)
