WOOD DESTROYING PESTS AND ORGANISM INSPECTION REPORT

Building No. 3280	Street Julio Avenue	City San Jose	ZIP 95124	Date of Inspection 5/24/2011	Number of Pages Page 1 of 8

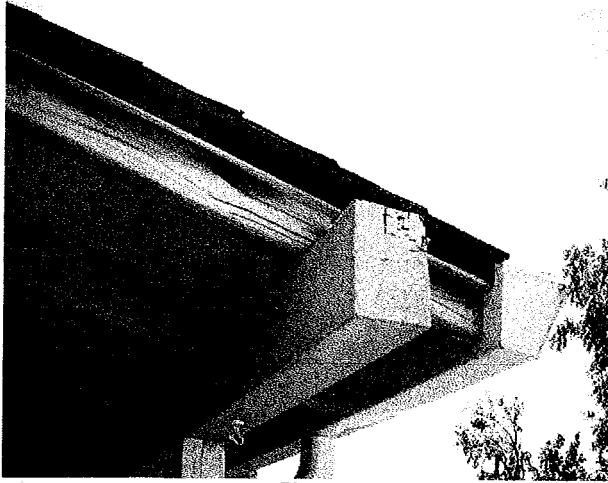
Picture 1

1A. FINDING: Fungus Damage was found to the exposed ends of the decorative beam's at the front left. (See Picture 1)

RECOMMENDATION: Cut back and remove approximately 8 inches from the end of the beam's to correct this condition. Paint end of beam with one coat of primer or one coat of color provided by owner.

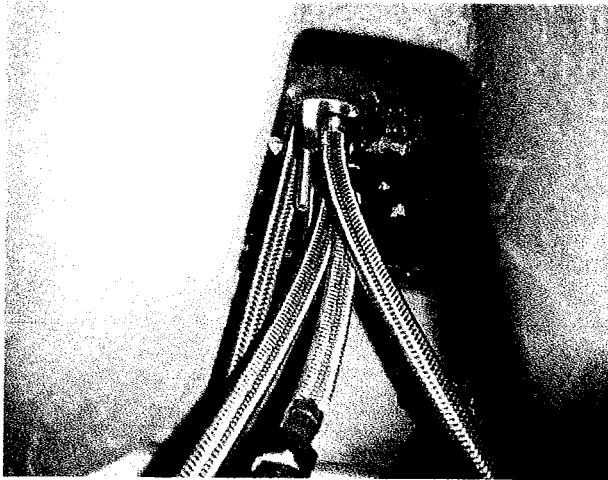
Picture 3

1D. FINDING: Water has penetrated through the kitchen counter top and has caused fungus damage. (See Picture 3)

RECOMMENDATION: Remove the existing counter top. Remove and replace any fungus damaged wood members. Install a new ceramic tile counter top in this area. Unless prior arraignments have been made all tile is bid using a standard grade white tile with a tight white grout joint. It should also be noted that all tile work regardless of color selection will be done with a tight white grout joint unless specified differently.
