# Roof Inspection Report

**1430 Lost Acre Drive, Felton**

**Kenneth Carlin**  
**November 12, 2010**  
**Report No. 146442**

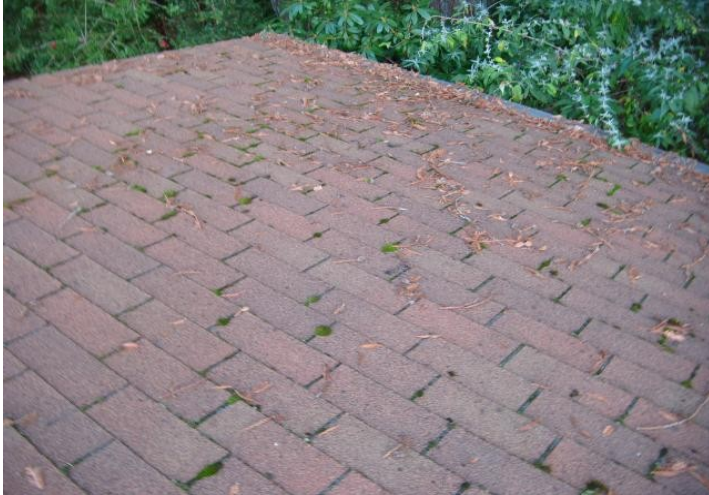
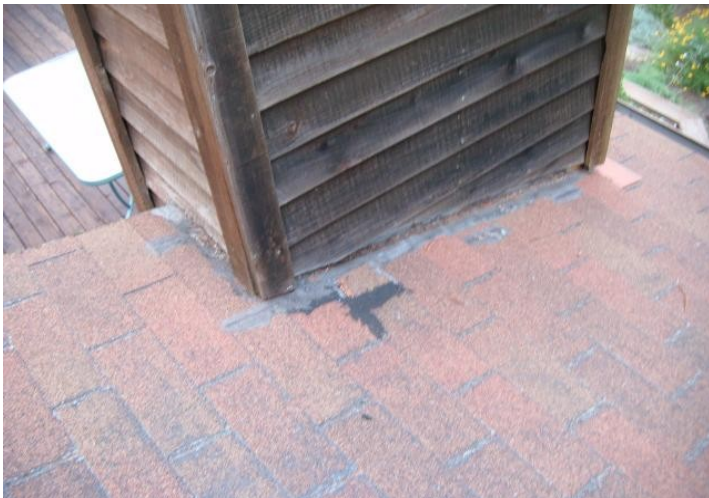
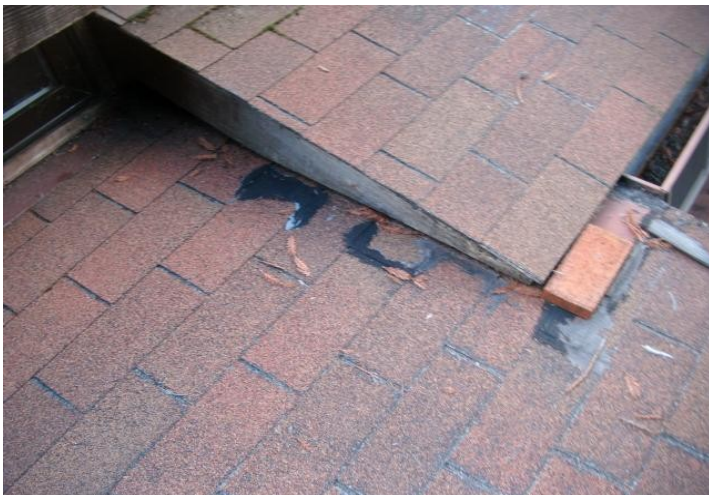
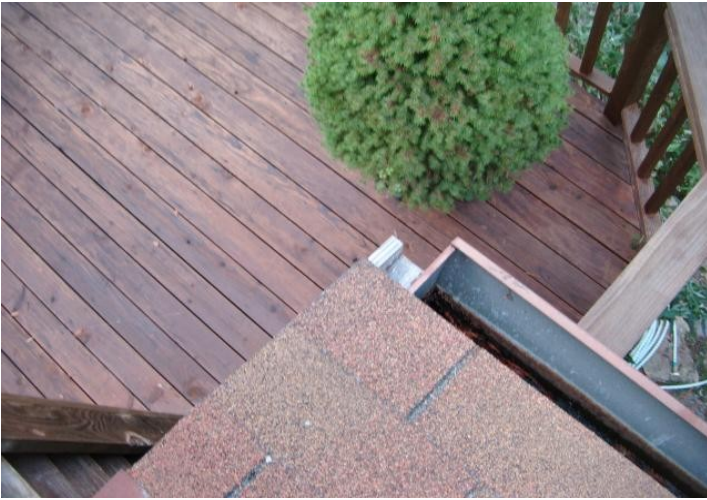
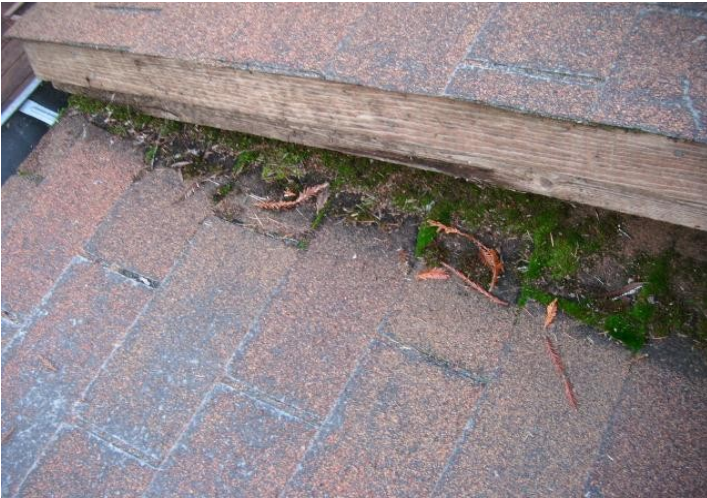
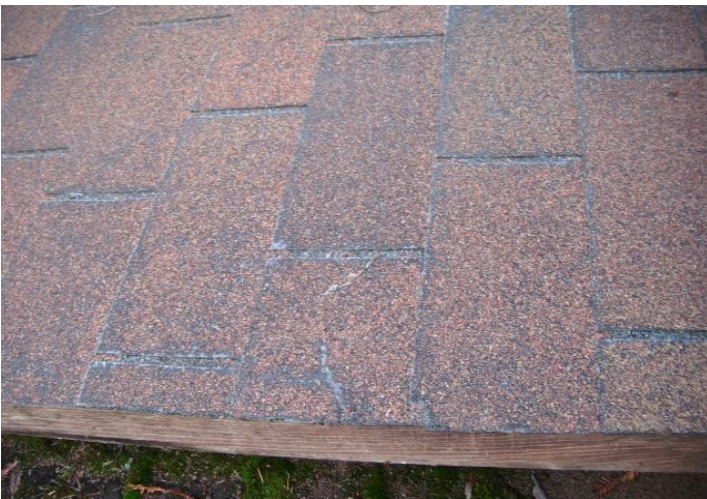
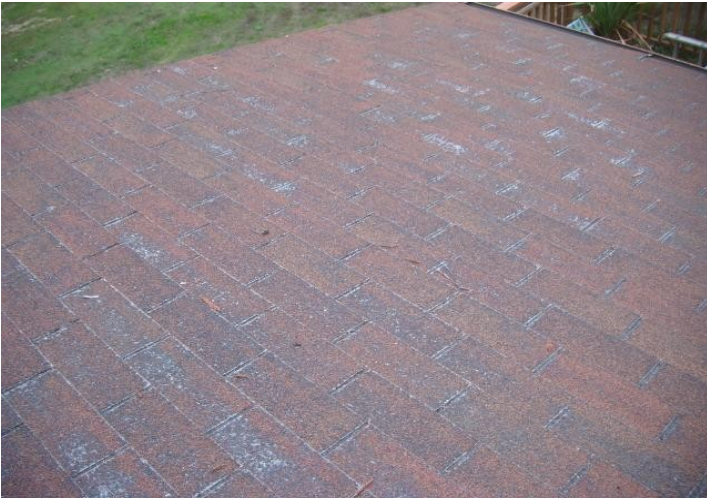
The detached structures were not a part of this inspection. The roof is a 3 tab composition shingle, brown in color and is the first layer. The typical life expectancy of this roofing material is 20+ years. The roof has the wear characteristics of being approximately 30+ year(s) old. The overall condition of the roof is poor.

1. The roof shows the wear characteristics of a roof that is beyond its intended life and practical repair. (See Picture 1) (See Picture 2) (See Picture 3) (See Picture 4) (See Picture 5) (See Picture 6) (See Picture 7)
2. The chimney has an inappropriate type of roofing material for its pitch. This material will not shed water properly and subsequently it may leak. The performance of this roof cannot be guaranteed. We recommend the roof be replaced at this area. (See Picture 8)

The roof appears vulnerable to leakage and is beyond practical repair. Interested parties are advised to contact a re-roofing contractor for re-roofing options.
