## WOOD DESTROYING PESTS AND ORGANISM INSPECTION REPORT

Building No. <b>1430</b>	Street <b>Lost Acre Drive</b>	City <b>Felton</b>	ZIP <b>95018</b>	Date of Inspection <b>11/12/2010</b>	Number of Pages <b>Page 1 of 11</b>

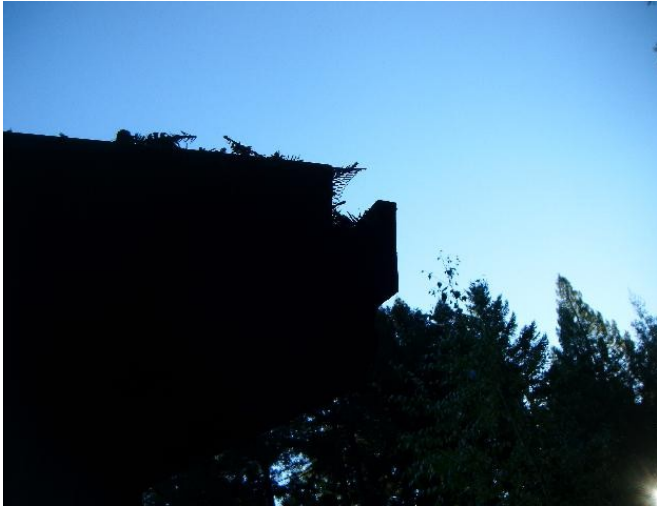
Picture 1

**1A. FINDING:** Fungus damage was noted to the barge rafter as indicated on the diagram. (See Picture 1)

**RECOMMENDATION:** Remove and replace the entire wood members to correct this condition. This bid includes replacement of the roof covering if disturbed by our repairs. If existing gutters need to be removed to perform the repairs then our bid also includes reinstallation of original gutters. If it becomes necessary or desirable to install new gutters this will be done only if authorized and at an additional cost. The guarantees on the roof covering are limited to the areas where the work was performed

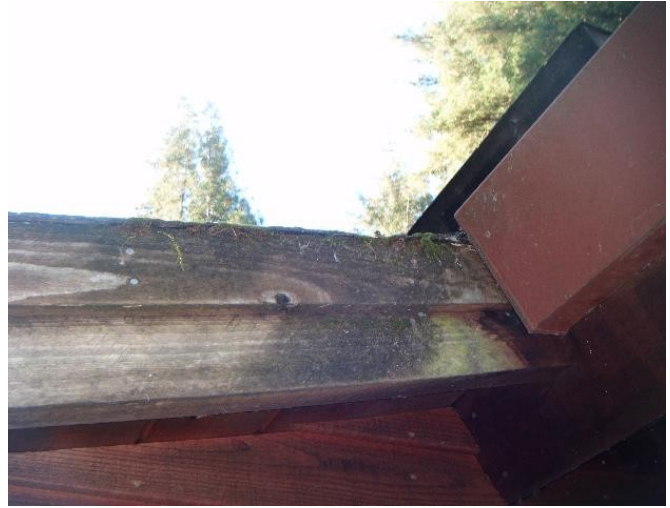
Picture 2

**1B. FINDING:** Fungus damage was noted to the trim and fascia as indicated on the diagram. (See Picture 2)

**RECOMMENDATION:** Remove and replace the damaged wood members to correct this condition. This bid includes replacement of the roof covering if disturbed by our repairs. If existing gutters need to be removed to perform the repairs then our bid also includes reinstallation of original gutters. If it becomes necessary or desirable to install new gutters this will be done only if authorized and at an additional cost. The guarantees on the roof covering are limited to the areas where the work was performed

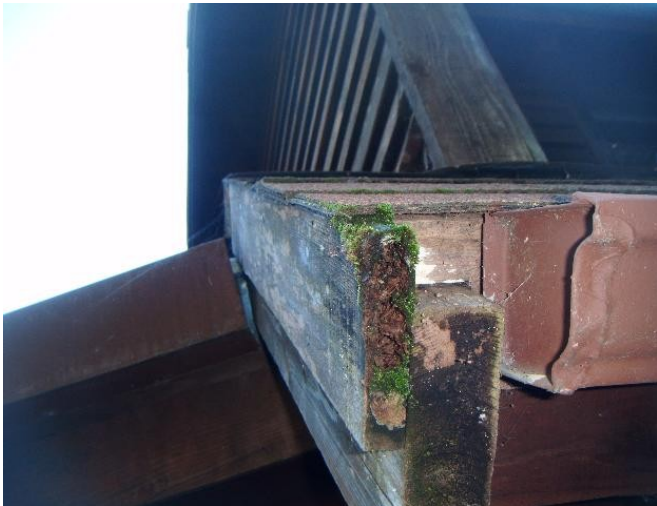
Picture 3

**1C. FINDING:** The trim has been damaged by fungus at the areas indicated on the diagram. (See Picture 3)

**RECOMMENDATION:** Remove and replace all the damaged wood members. If any damage is found to extend into any enclosed areas a supplemental report and bid will be issued.

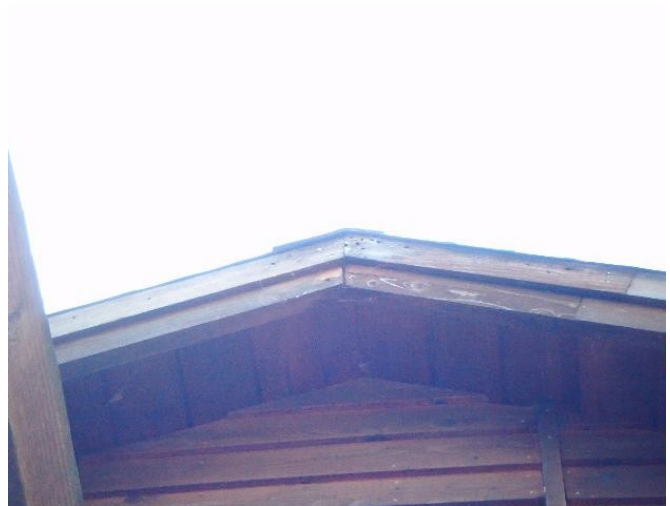
Picture 4

**1D. FINDING:** The trim barge rafter has been damaged by carpenter bees at the area indicated on the diagram. (See Picture 4)

**1E. FINDING:** There is evidence of an infestation of Carpenter Bees at the trim and barge rafter. (See Picture 4)

**RECOMMENDATION:** Remove and replace all the damaged wood members. If any damage is found to extend into any enclosed areas a supplemental report and bid will be issued.

**RECOMMENDATION:** Treat the infested areas with a registered pesticide Timbor (Disodium Octoborate Tetrahydrate) then fill all emergence holes with steel wool. NOTE: In order to perform this treatment the property will need to be vacated for a period of 3 hours after the treatment is performed.

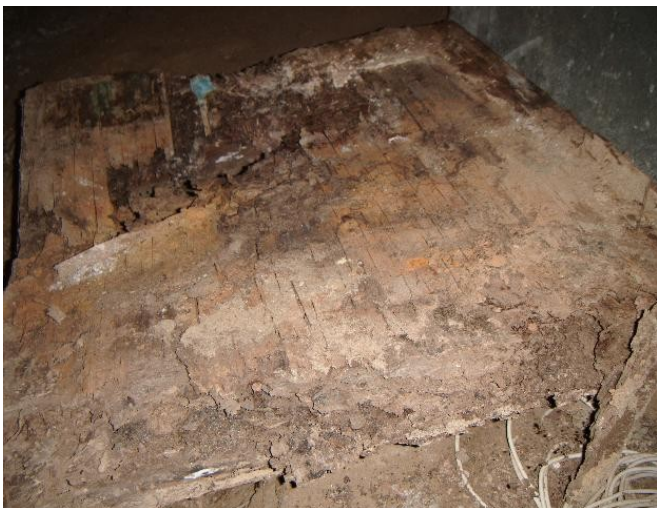
Picture 5

**1F. FINDING:** There is fungus infected and subterranean termite infested cellulose debris in earth contact in the substructure area. (See Picture 5)

**1G. FINDING:** There is evidence of a Subterranean Termite infestation in the substructure area soil. (See Picture 5)

**1H. FINDING:** There is evidence of Subterranean Termite migratory tubes as noted in the above recommendation. (See Picture 5)

**RECOMMENDATION:** Remove cellulose debris of a size that can be raked from the substructure area.

**RECOMMENDATION:** Treat the affected areas with Termidor SC (Fipronil:5-amino-1-(2,6-dichloro-4-(trifluoromethyl) phenyl)-4-((1,8,5)-trifluoromethyl)sulfinyl)-1-H-pyrazole-3-carbonitrile. NOTE: In order to perform this treatment the property will need to be vacated for the period during and 3 hours after the treatment is performed.

**RECOMMENDATION:** Break down & brush away all termite migratory tubes.

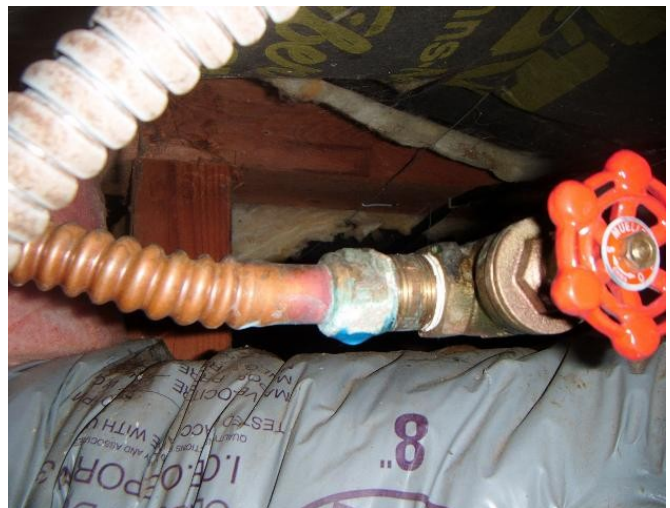
Picture 6

**2E.** FINDING: The plumbing fittings at the water heater left side in subarea were noted to be heavily corroded. Active leakage was not evident at this time. (See Picture 6)

RECOMMENDATION: Repair or replace the corroded fittings to prevent against leakage.

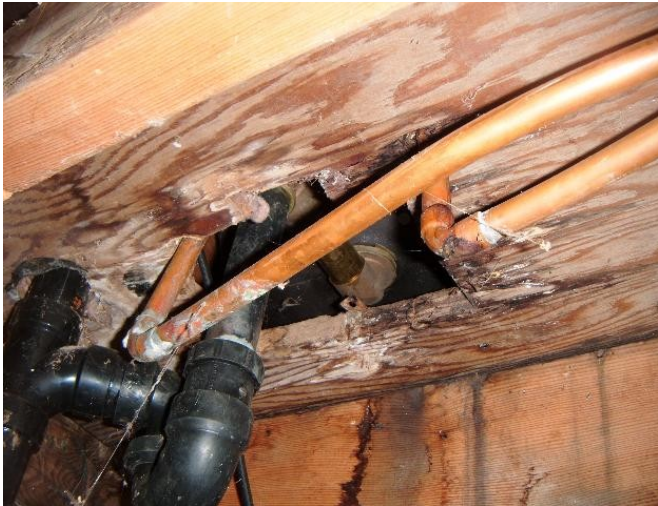
Picture 7

**1I. FINDING:** There is a surface fungus condition located under the hall bathroom subfloor. (See Picture 7)

**RECOMMENDATION:** Scrape or wire brush this area and treat with a registered fungicide Timbor (Disodium Octoborate Tetrahydrate). NOTE: In order to perform this treatment the property will need to be vacated during and 3 hours after the treatment is performed.

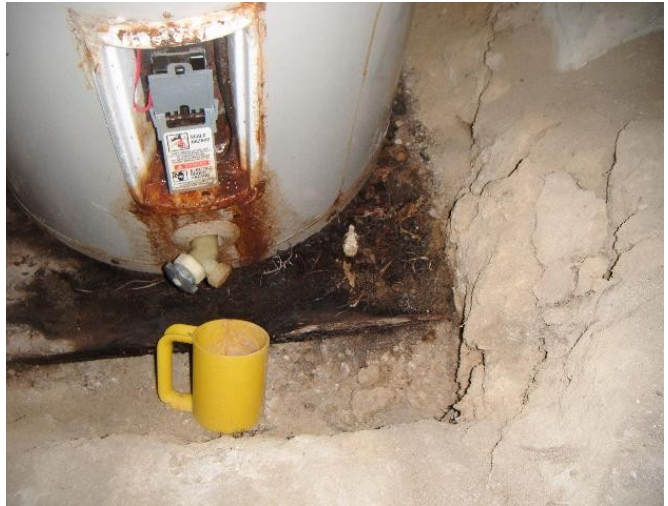
Picture 8

**1J. FINDING:** There are water heater plat form in earth contact in the substructure area. (See Picture 8)

**2C.** FINDING: There is evidence of leakage from the water heater at the right side in subarea.  
(See Picture 8)

**RECOMMENDATION:** Remove as much of the water heater plat form as practical and chemically treat the remainder with Termidor SC (Fipronil:5-amino-1-(2,6-dichloro-4-(trifluoromethyl) phenyl)-4-((1,8,5)-trifluoromethyl)sulfinyl)-1-H-pyrazole-3-carbonitrile.

RECOMMENDATION: Replace the water heater to correct this condition. The bid for this item includes new seismic strapping if necessary, new water supply flex lines, and a new gas supply flex line. If any other changes are deemed necessary by the local building authority a supplemental report and bid will be issued.

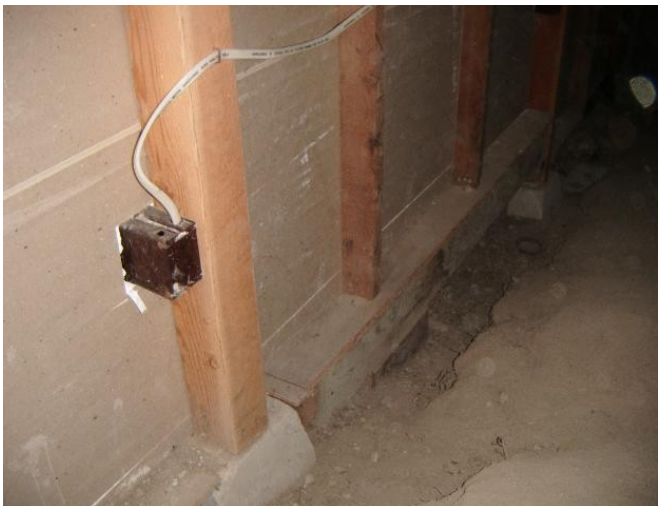
Picture 9

**3A.** FINDING: A portion of the structure at the basement off the subarea appears to be sleeper floor construction and was inaccessible for physical inspection. No outward signs of infestations or infections were visible at this time. (See Picture 9)

RECOMMENDATION: Open the sleeper floor to allow for further inspection. All findings, recommendations, and bids will be issued in a supplemental report.

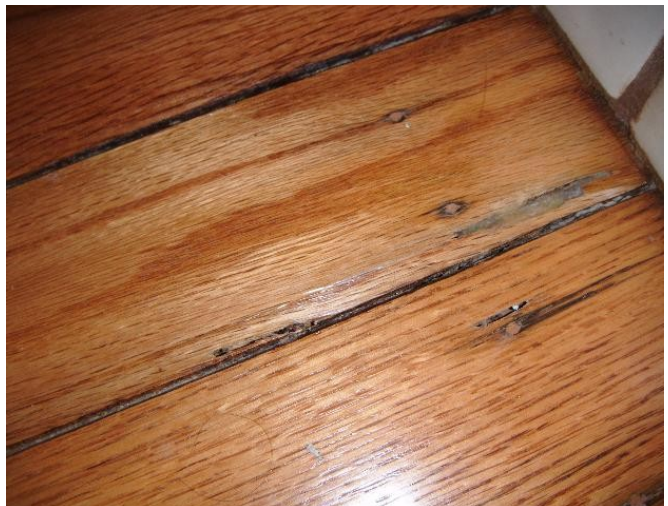
Picture 10

**1K.** FINDING: The hardwood floors have been damaged by drywood termites at the hall bathroom. (See Picture 10)

RECOMMENDATION: Remove and replace all the damaged wood members. If any damage is found to extend into any enclosed areas a supplemental report and bid will be issued.

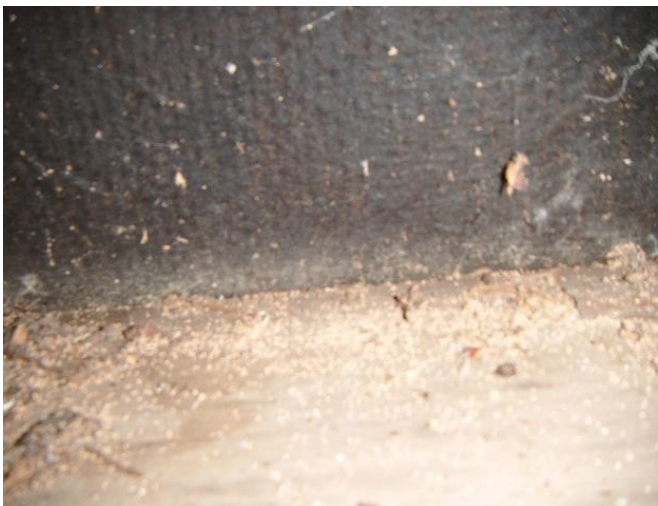
Picture 11

**1L.** FINDING: Infestation by Drywood Termites was noted at the interior and subarea. (See Picture 11)

**1M.** FINDING: Drywood termite pellets were evident as noted in the above recommendation. (See Picture 11) (See Picture 12)

RECOMMENDATION: Due to the nature of these infestations, it will be necessary to seal the entire structure and fumigate it with Vikane (sulfuryl fluoride), using Chloropicrin as a warning agent. The entire structure must be vacant for this process. It is the owners responsibility to make any preparations required by the fumigators or to have someone to do so at a separate expense and to have the gas turned back on when the fumigation is complete. Due to current Cal OSHA Safety Standards work above 7.5 feet demands fall protection, this requires the installation of anchor points at the roof ridge line. HomeGuard will repair any damage caused by the installation of the anchor. However, in the case of metal roof coverings it is the owners responsibility to make areas on the roof ridge accessible to secure the anchors. HomeGuard Incorporated guarantees all fumigations for a period of two years.

RECOMMENDATION: Remove and/or mask over all accessible termite pellets. It is possible for the Drywood Termite pellets to sift down or reappear in these areas where they have been masked over.
