Property Inspection Report

1209 Melba Court, San Jose, CA 95120

Robert Scott Ripke
June 22, 2011
Report No. 151419

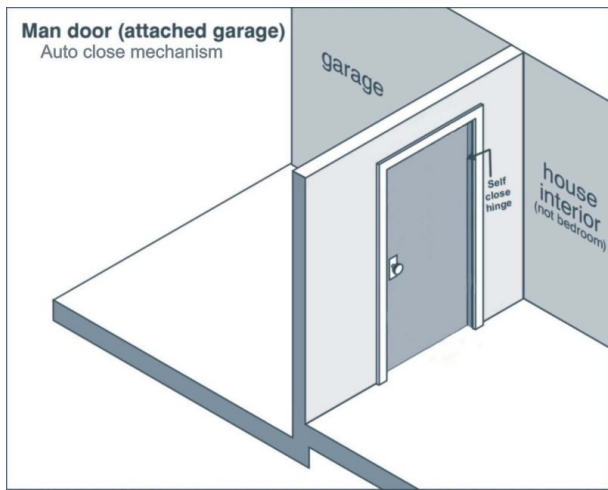
Illustration 6B

1. The main garage door jamb and/or trim shows evidence of water damage. Repairs should be undertaken as necessary by the appropriate trades. (See Picture 1) (See Picture 2)
2. Water stains were noted on the ceiling of the garage. This is usually an indication of past plumbing or roof leaks. This area should be further evaluated by the appropriate trades.
3. The door between the garage and the interior of the house should be fitted with an automatic closer mechanism. This will reduce the potential of toxic automobile gases entering the house and serves as a fire break. (See Illustration 6B)

- ! 1. The main garage door jamb and/or trim shows evidence of water damage. Repairs should be undertaken as necessary by the appropriate trades. (See Picture 1) (See Picture 2)
- ! 2. Water stains were noted on the ceiling of the garage. This is usually an indication of past plumbing or roof leaks. This area should be further evaluated by the appropriate trades.
- ! 3. The door between the garage and the interior of the house should be fitted with an automatic closer mechanism. This will reduce the potential of toxic automobile gases entering the house and serves as a fire break. (See Illustration 6B)
- 4. There are minor sized cracks in the exterior stucco that should be patched and sealed as part of preparation for the next painting. Flexible patching materials are recommended rather than rigid patching compounds.

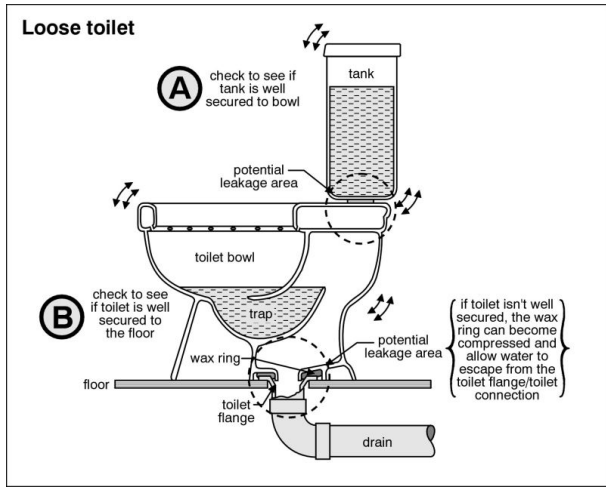
Illustration 5B1

6. The toilet in the master bath is loose and should be properly re-secured, tightened and caulked. (See Illustration 5B1)

- ! 1. The toilet in the master bath is loose and should be properly re-secured, tightened and caulked. (See Illustration 5B1)
2. The plastic landscape supply piping does not have sufficient support to prevent it from sagging. Additional support or bracing is recommended. (See Picture 5)

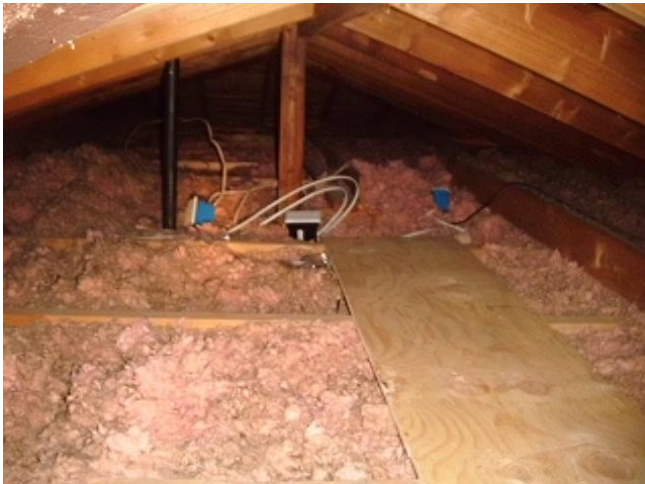
Picture 3

4. There are loose junction boxes and wiring in the attic. (See Picture 3)
5. Abandoned wiring was noted. We recommend the wiring be disconnected at its source or terminated in an approved manner in a covered junction box.

- ! 1. There are loose junction boxes and wiring in the attic. (See Picture 3)
- ! 2. Abandoned wiring was noted. We recommend the wiring be disconnected at its source or terminated in an approved manner in a covered junction box.
- 3. The circuitry in the main panel is not labeled. We recommend this be corrected to allow individuals unfamiliar with the equipment to operate it properly when and if necessary. (See Picture 1)
