WOOD DESTROYING PESTS AND ORGANISM INSPECTION REPORT

Building No. 1209	Street Melba Court	City San Jose	ZIP 95120	Date of Inspection 6/22/2011	Number of Pages Page 1 of 9

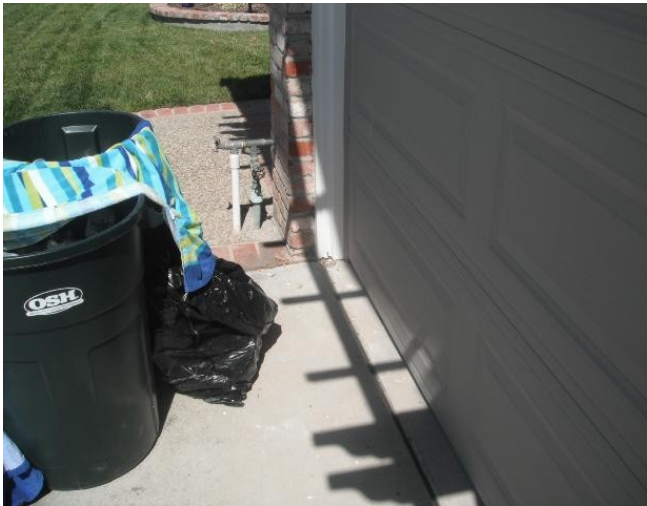
Picture 1

1A. FINDING: The main garage door jambs are fungus and drywood termite damaged. (See Picture 1)

RECOMMENDATION: Cut off the bottom of the door jambs and fill the void with concrete.
***** (SECTION 1 ITEM) *****

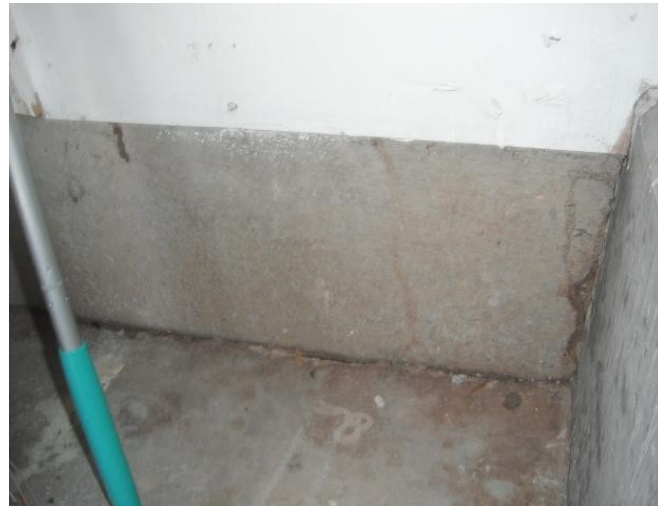
Picture 2

1C. FINDING: There is evidence of subterranean termite migratory tubes as noted in the above recommendation. (See Picture 2)

RECOMMENDATION: Break down and brush away all subterranean termite migratory tubes.
***** (SECTION 1 ITEM) *****

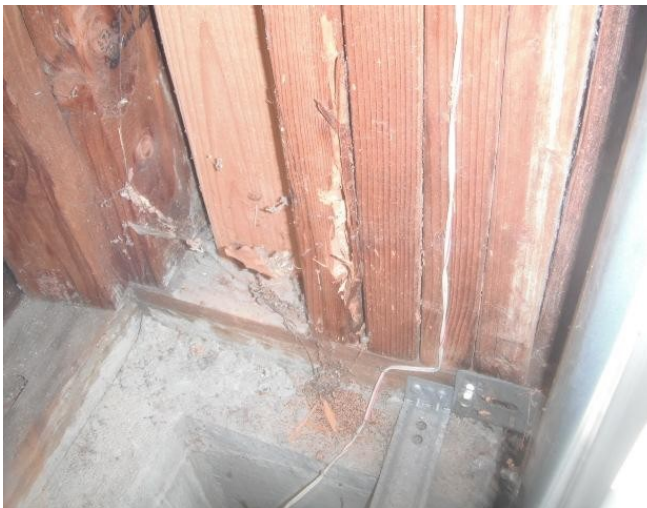
Picture 3

1D. FINDING: The 2x4 stud has been damaged by drywood termites at the garage. (See Picture 3)

RECOMMENDATION: Remove and replace all the damaged wood members. If any damage is found to extend into any enclosed areas a supplemental report and bid will be issued.
***** (SECTION 1 ITEM) *****
