WOOD DESTROYING PESTS AND ORGANISM INSPECTION REPORT

Building No. 463	Street Nolden Avenue	City San Jose	ZIP 95117	Date of Inspection 6/23/2010	Number of Pages Page 1 of 7
----------------------------	--------------------------------	-------------------------	---------------------	--	---------------------------------------

HomeGuard Rpt #: **143148**

General Description: Two story, single family wood framed residence with wood and stucco exterior.	Inspection Tag Posted: Garage
	Other Tags Posted: Able 10/09

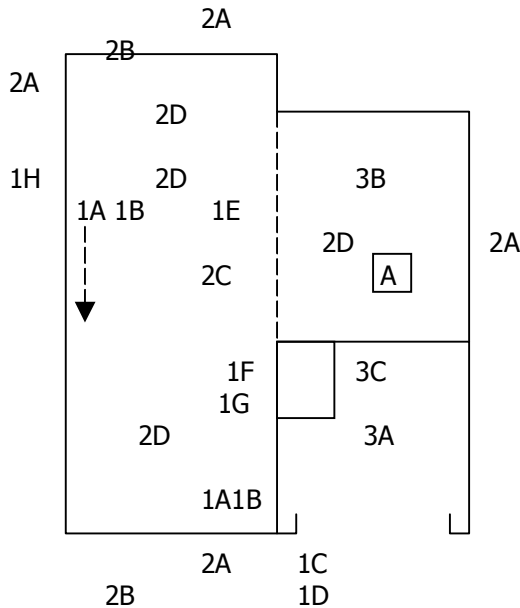
FRONT
Diagram Not To Scale

Key to Items on diagram: [1] Section 1 Items [2] Section 2 Items [3] Unknown Further Inspection Items

1C. FINDING: Fungus damage was noted to the roof eaves as indicated on the diagram.

1D. FINDING: Fungus damage was noted to the rafters as indicated on the diagram.

2A. FINDING: Minor stress cracks were noted in the exterior stucco as indicated on the diagram.
