Property Inspection Report

231 Purple Glen Drive, San Jose, CA 95119

Robert Scott Ripke
July 14, 2011
Report No. 151863

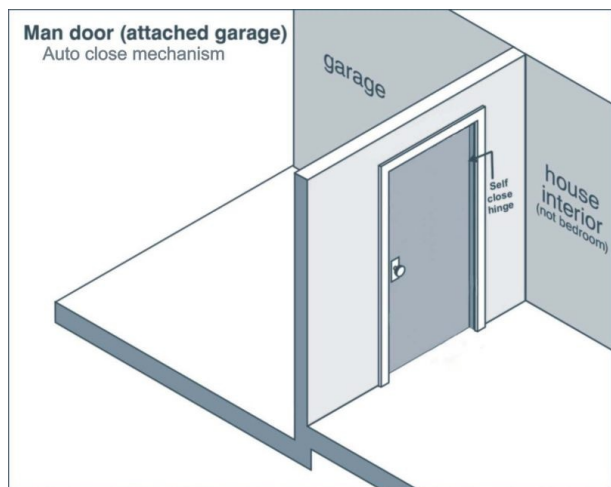
Illustration 6B

- ! 3. The door between the garage and the interior of the house should be fitted with an automatic closer mechanism. This will reduce the potential of toxic automobile gases entering the house and serves as a fire break. (See Illustration 6B)

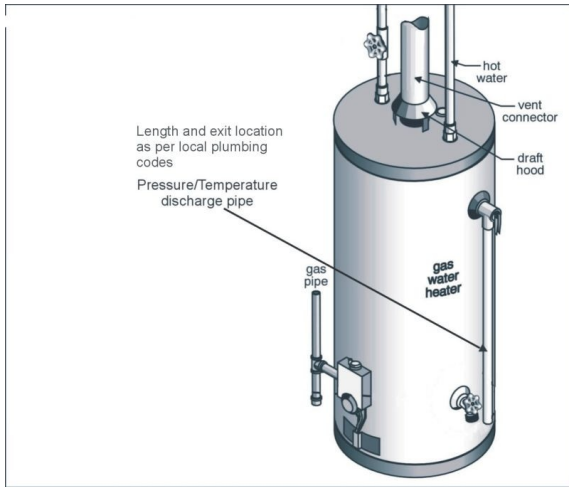
Illustration 9AF

- ! 1. The temperature and pressure relief valve for the water heater lacks a proper length discharge pipe. We recommend the installation of approved piping to an approved location. (See Illustration 9AF) (See Picture 8)

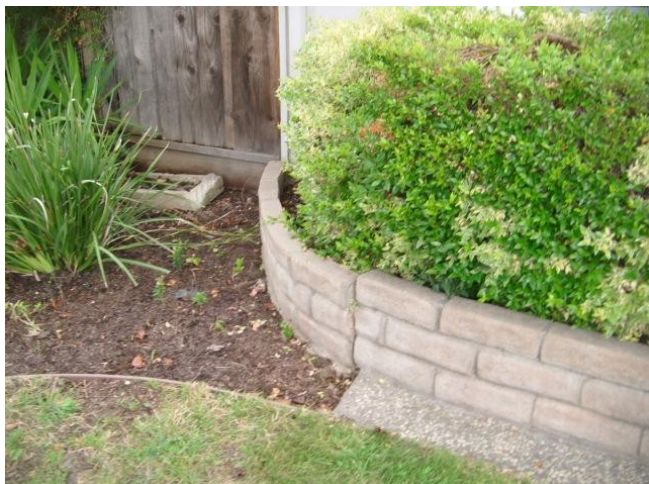
Picture 1

7. The front decorative retaining walls/planters are damaged. We recommend they be repaired or replaced for better appearance and prolonged service, but this is in large measure an aesthetic issue. (See Picture 1)

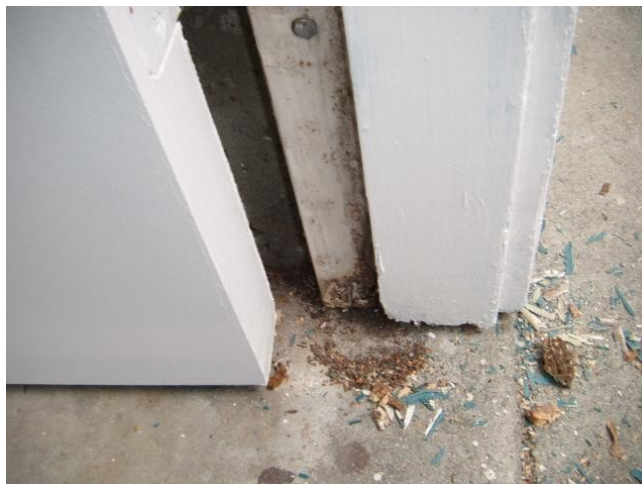
Picture 2

- ! 8. The exterior side or rear garage door jamb is water damaged. We recommend it be repaired or replaced by the appropriate trades. (See Picture 2)

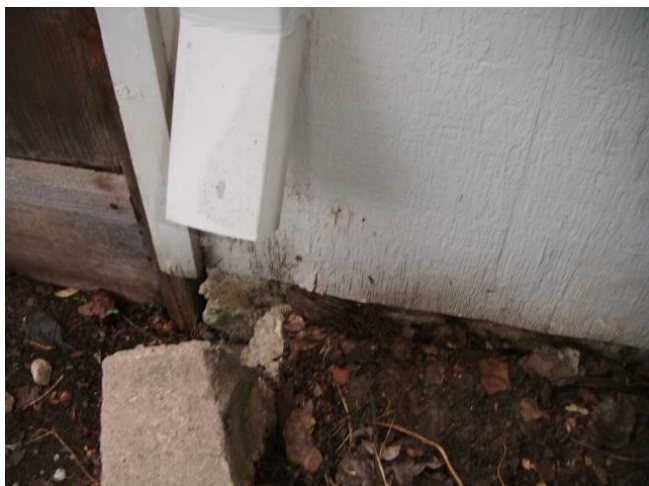
Picture 3

- ! 5. Water damage was observed to the wood siding in the front exterior walls. We recommend the advice and services of a licensed general contractor and/or structural pest control company. (See Picture 3)

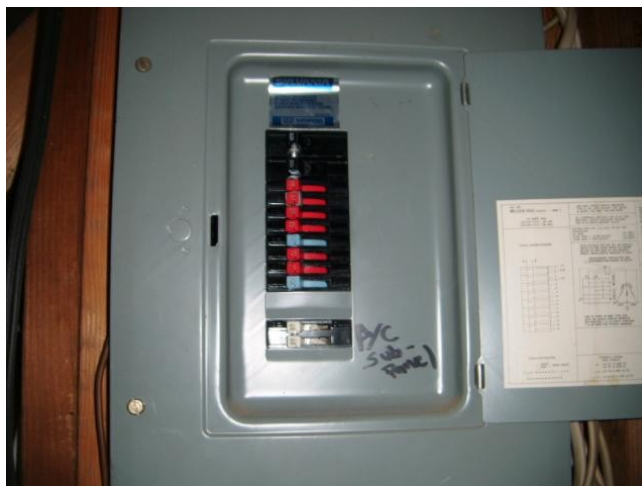
Picture 4

- ! 2. The loose or improperly installed light fixture in the garage should be repaired or replaced as necessary. (See Picture 12)
3. The circuitry in the main panel is not labeled. We recommend this be corrected to allow individuals unfamiliar with the equipment to operate it properly when and if necessary. (See Picture 4)

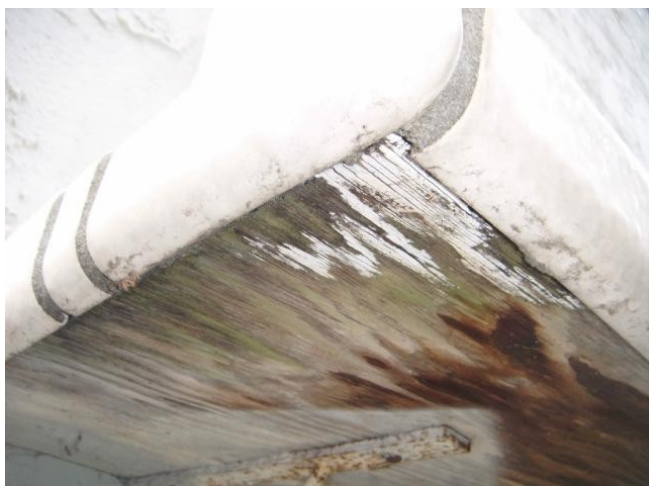
Picture 5

- ! 6. Damage was observed in the planter shelf. We recommend the advice and services of the appropriate trades regarding repairs to this area. (See Picture 5)

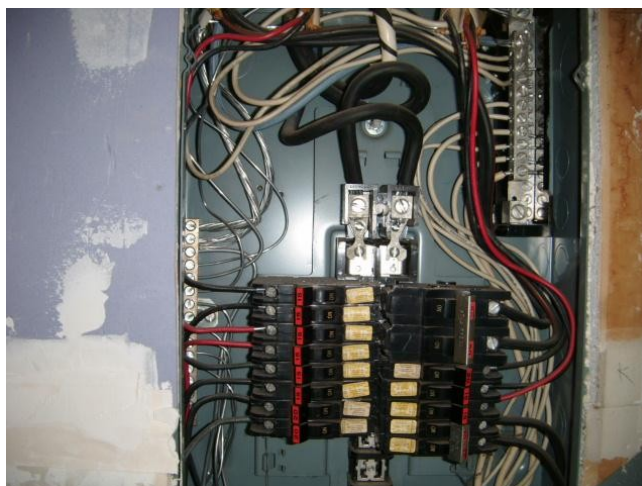
Picture 6

1. Aluminum wiring has been used for 120 volt wiring circuits. The Consumer Product Safety Commission has determined that if not properly installed, aluminum wiring can be hazardous. It should be pointed out that the aluminum wiring itself is a perfectly acceptable electrical conductor. The connection points can experience overheating or become loose due to the properties of aluminum wiring. Aluminum wiring should be fitted with special copper connectors and outlets to ensure safe operation of these circuits. As a preventive measure, we recommend that each aluminum connection be periodically checked by a qualified and licensed electrician to insure that it is properly fastened with no evidence of overheating or arcing noted. (See Picture 6)

6. We have observed a Federal Pacific electrical "Stab lock" service panel(s) in this house. This type of panel has a past history of circuit breakers failing to trip in response to a over current or short circuit. Failure of a circuit breaker to trip does not afford the protection that is intended and required. We recommend a licensed electrician be retained for additional information and recommendations. (See Picture 6)

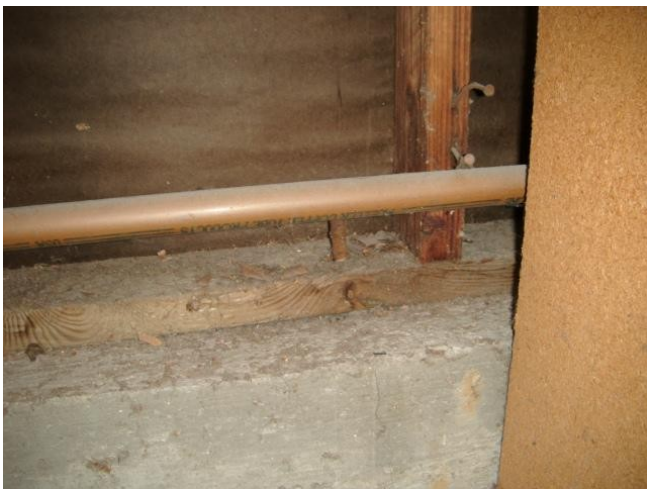
Picture 9

1. There is a condition known as efflorescence on portions of the foundation walls. This fuzzy material is a salt deposit left when moisture in the foundation evaporates on the inside of the foundation. This indicates an occasional surplus of moisture on the outside of the foundation. Steps could be taken to improve the exterior drainage (See "Roofing" section downspout locations for additional comments/recommendations in regard to this condition).
- ! 2. Some of the garage anchor bolts washers and nuts are missing and/or loose, rendering the bolts ineffective for their intended purpose. We recommend all loose and/or missing parts be installed in accordance with present standards. (See Picture 9)

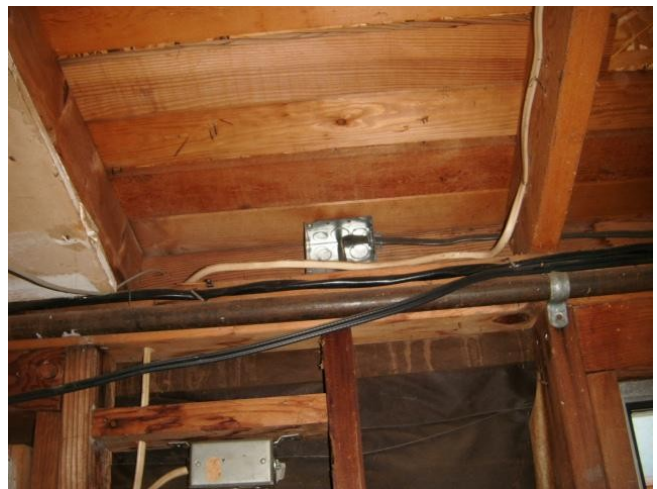
Picture 10

- ! 2. Water stains were noted on the walls of the garage. This is usually an indication of past plumbing or roof leaks. This area should be further evaluated by the appropriate trades. (See Picture 10)

- ! 4. Exposed electrical connections or open junction box(s) in the garage should be improved. All electrical connections should be made inside approved junction boxes fitted with cover plates. (See Picture 10)
