**WOOD DESTROYING PESTS AND ORGANISM INSPECTION REPORT**

Building No. <b>231</b>	Street <b>Purple Glen Drive</b>	City <b>San Jose</b>	ZIP <b>95119</b>	Date of Inspection <b>7/14/2011</b>	Number of Pages <b>Page 1 of 6</b>
----------------------------	------------------------------------	-------------------------	---------------------	--	---------------------------------------

HomeGuard Rpt #: **151863**

General Description: <b>Two story, single family wood framed residence with wood and stucco exterior.</b>	Inspection Tag Posted: <b>Garage</b>
	Other Tags Posted: <b>None noted</b>

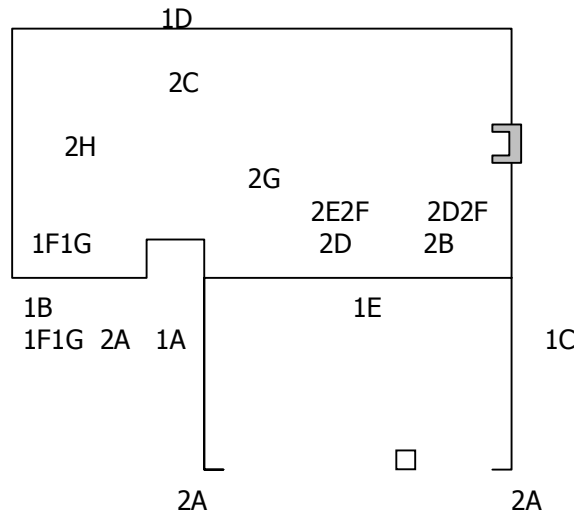
**FRONT**  
**Diagram Not To Scale**

**Key to Items on diagram: [1] Section 1 Items [2] Section 2 Items [3] Unknown Further Inspection Items**
