**WOOD DESTROYING PESTS AND ORGANISM INSPECTION REPORT**

Building No. <b>1381</b>	Street <b>Zurich Terrace</b>	City <b>Sunnyvale</b>	ZIP <b>94087</b>	Date of Inspection <b>6/30/2010</b>	Number of Pages <b>Page 1 of 6</b>
-----------------------------	---------------------------------	--------------------------	---------------------	--	---------------------------------------

HomeGuard Rpt #: **143233**

General Description: <b>Two story, wood framed townhouse with wood and stucco exterior. Limited to the interior and garage interior only.</b>	Inspection Tag Posted: <b>Garage</b>
	Other Tags Posted: <b>None noted</b>

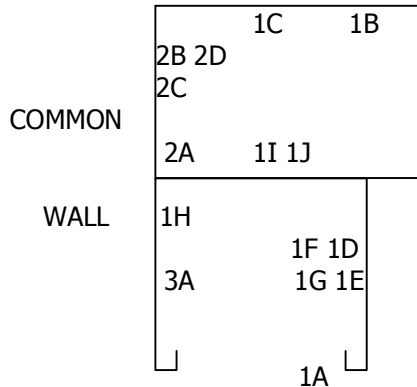
**FRONT**  
**Diagram Not To Scale**

**Key to Items on diagram: [1] Section 1 Items [2] Section 2 Items [3] Unknown Further Inspection Items**
