# Property Inspection Report

**2431 Plummer Avenue, San Jose, CA 95125**

Donald Grenier  
January 27, 2010  
Report No. 138642

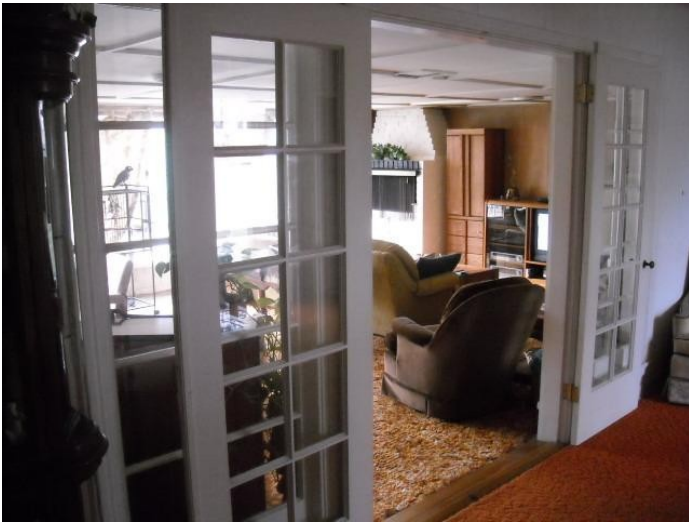
Picture 14

8. Damaged or cracked siding was noted at the left side exterior wall. We recommend the siding be repaired or replaced as necessary. (See Picture 4)
9. The side decorative shutters are damaged. We recommend they be repaired or replaced as necessary. (See Picture 3)
10. Cracked or broken exterior window's glass at the rear and front should be replaced. (See Picture 7)
11. The window frames/sash at the side wall show evidence of water damage. Repair or replacement is recommended by appropriate trades. (See Picture 14) (See Picture 15)

- ! 4. The window frames/sash at the side wall show evidence of water damage. Repair or replacement is recommended by appropriate trades. (See Picture 14) (See Picture 15)
