Property Inspection Report

3280 Julio Avenue, San Jose, CA 95124

Robert Ripke
May 24, 2011
Report No. 150598

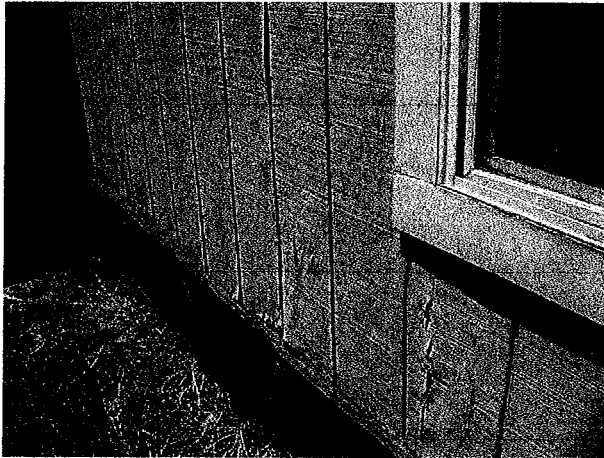
Picture 8

5. Water damage was observed to the wood siding in the exterior walls by the rear patio room. We recommend the advice and services of a licensed general contractor and/or structural pest control company. (See Picture 8)

- ! 6. Water damage was observed to the wood siding in the exterior walls by the rear patio room. We recommend the advice and services of a licensed general contractor and/or structural pest control company. (See Picture 8)

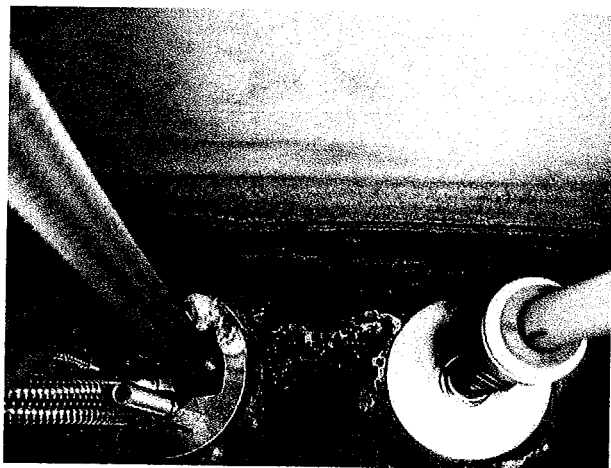
Picture 14

10. The clean out cap is missing at the right. We recommend replacing the cap to prevent sewage spillage and odor. (See Picture 10)
11. The water heater vent pipe or hood is loose and exhaust leakage was evident. This is a potential safety concern that should be addressed. We recommend the vent and hood be properly installed as necessary. (See Picture 14)

- ! 1. The clean out cap is missing at the right. We recommend replacing the cap to prevent sewage spillage and odor. (See Picture 10)
- ! 2. The water heater vent pipe or hood is loose and exhaust leakage was evident. This is a potential safety concern that should be addressed. We recommend the vent and hood be properly installed as necessary. (See Picture 14)

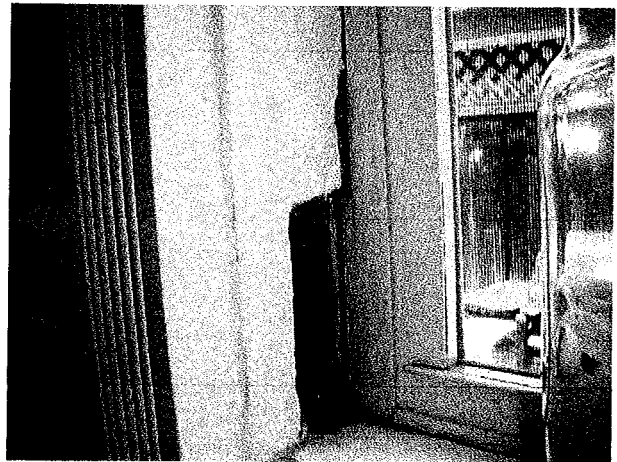
Picture 21

8. Cracked or broken window's glass at the middle bedroom should be replaced. (See Picture 20) (See Picture 21)

- ! 1. Cracked or broken window's glass at the middle bedroom should be replaced. (See Picture 20) (See Picture 21)
- ! 2. The door between the garage and the interior of the house should be fitted with an automatic closer mechanism. This will reduce the potential of toxic automobile gases entering the house and serves as a fire break. (See Illustration 6B)
