Property Inspection Report

231 Purple Glen Drive, San Jose, CA 95119

Robert Scott Ripke
July 14, 2011
Report No. 151863

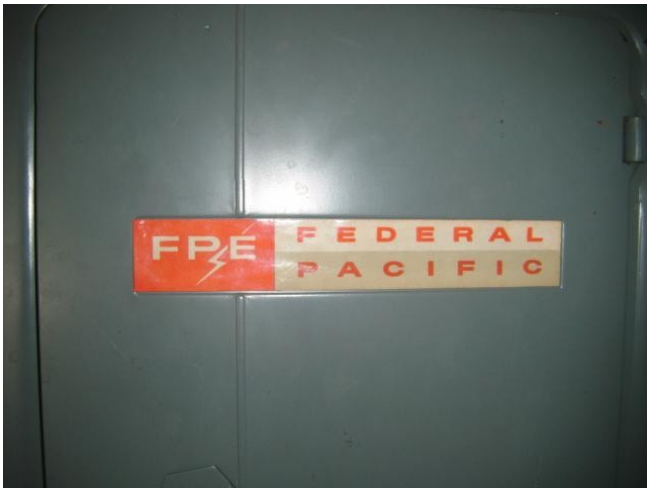
Picture 6

1. Aluminum wiring has been used for 120 volt wiring circuits. The Consumer Product Safety Commission has determined that if not properly installed, aluminum wiring can be hazardous. It should be pointed out that the aluminum wiring itself is a perfectly acceptable electrical conductor. The connection points can experience overheating or become loose due to the properties of aluminum wiring. Aluminum wiring should be fitted with special copper connectors and outlets to ensure safe operation of these circuits. As a preventive measure, we recommend that each aluminum connection be periodically checked by a qualified and licensed electrician to insure that it is properly fastened with no evidence of overheating or arcing noted. (See Picture 6)

6. We have observed a Federal Pacific electrical "Stab lock" service panel(s) in this house. This type of panel has a past history of circuit breakers failing to trip in response to a over current or short circuit. Failure of a circuit breaker to trip does not afford the protection that is intended and required. We recommend a licensed electrician be retained for additional information and recommendations. (See Picture 6)

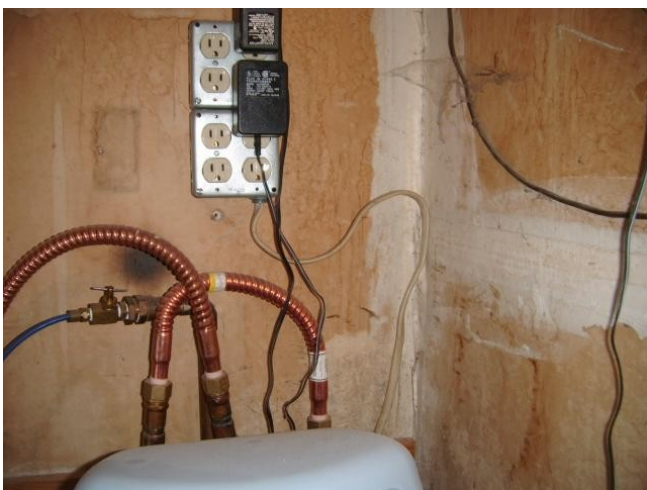
Picture 10

- ! 2. Water stains were noted on the walls of the garage. This is usually an indication of past plumbing or roof leaks. This area should be further evaluated by the appropriate trades. (See Picture 10)

- ! 4. Exposed electrical connections or open junction box(s) in the garage should be improved. All electrical connections should be made inside approved junction boxes fitted with cover plates. (See Picture 10)
